## MSIU SAFETY ALERT 01/2013

Failure of lifeboat wire fall due to corrosion that resulted in five fatalities on the Maltese registered passenger vessel *Thomson Majesty*

MSIU SAFETY ALERT 01/2013

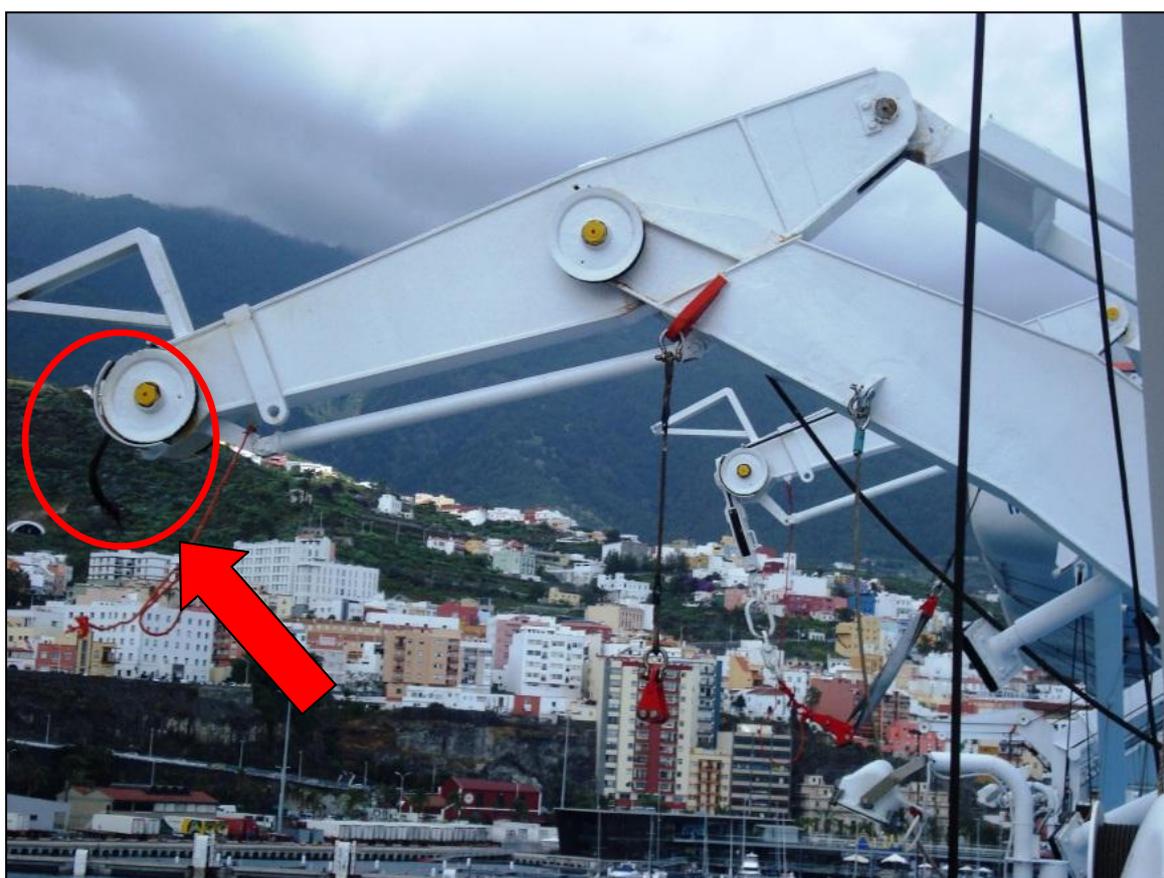
At about 1030, the ship commenced a General Emergency and Life Boat Drill for all crew members. Three lifeboats on the outboard side were to be lowered to the water and sent away for training purposes. During the recovery and hoisting of no. 9 lifeboat, the forward wire fall parted causing the boat to swivel on the aft hook. As the boat reached an angle of approximately 45° to the horizontal, the aft end of the boat and the hook failed and the boat dropped approximately 20 metres to the sea, turning upside down as it entered the water.

**Forward Davit Arm Showing Parted Wire**

The wire rope had parted approximately where it rested over the topmost sheave, when the davit was in a stowed position. The fore and aft davit's falls were replaced on 22 August 2010 and the next scheduled replacement was August 2014. The launching appliance had been dynamically tested in May 2012.

Initial results of the tests carried out on the parted ends of the wire indicate significant corrosion damage to the inner strands of the wire.

- Ensure that the falls are continuously well lubricated with an approved type of grease, particularly those areas that are difficult to inspect, where the falls pass through and around sheaves.
- Inspect regularly, frequently and thoroughly all visible parts of wire falls in order to detect general deterioration and deformation, including corrosion, abrasion, and mechanical damage.
- Review the contents of [MSC.1/Circ.1206/Rev.1](#) (Measures to Prevent Accidents with Lifeboats) and act accordingly.
