## SAFETY RECOMMENDATION No: 01/2013

01/2013: Loss of life of seaman after falling overboard passenger launch boat "Vaggelio".  
*(See the full Report [here.](#))*

### **Loss of life of seaman after falling overboard passenger launch boat**

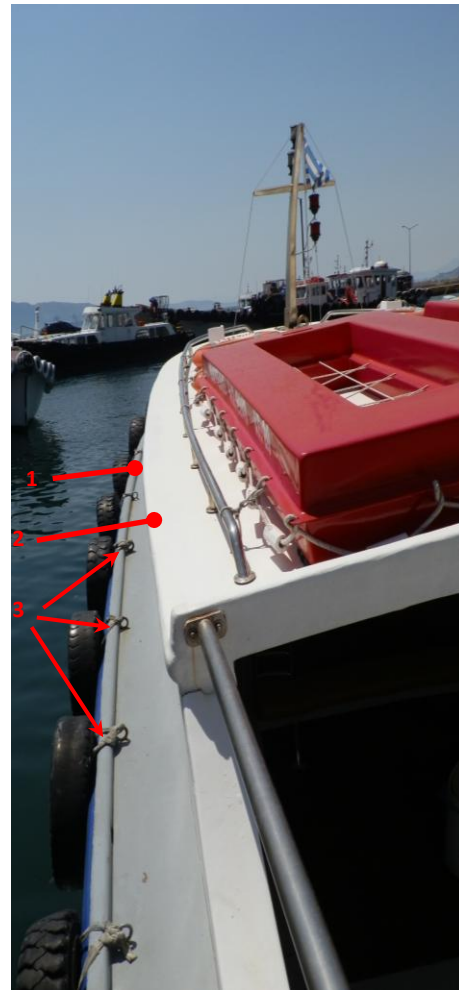
**Picture 2:** View from the stern of the left side deck of passenger launch. They are distinguished:

1. Handrail of board
2. Prominence of the superstructure
3. Pegs tire suspension
