SAFETY RECOMMENDATION No: 01/2014

No of Safety Investigation Report: 01/2014: Grounding and Foundering of F/V "AGIA MARINA" Registry of Mytilene no. 363
(See the full Report [here.](#))

Grounding and Foundering of F/V "AGIA MARINA", Registry of Mytilene no. 363

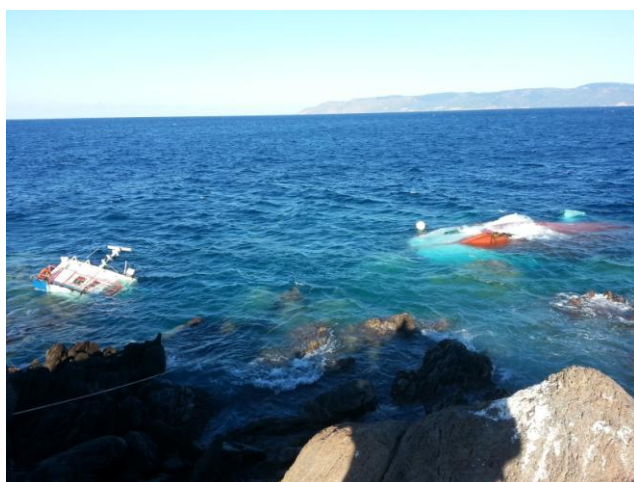
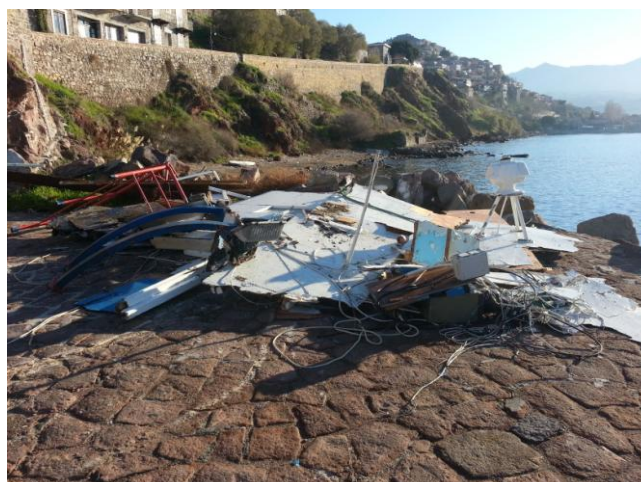
AGIA MARINA remained at the grounding spot and due to the sea conditions she sustained multiple breaches and was foundered the following day. Only few parts of her equipment were recovered, whereas all documents, including the Bridge Log Book were lost.

Photos from the vessel's total loss due to the sea conditions and the rocky coast and from her equipment parts which were recovered a few days after the accident.
