SAFETY RECOMMENDATION No: 01/2017

01/2017: Grounding of B/C “St. Gregory”
(See the full Report [here.](#))

Grounding of B/C “St. Gregory”

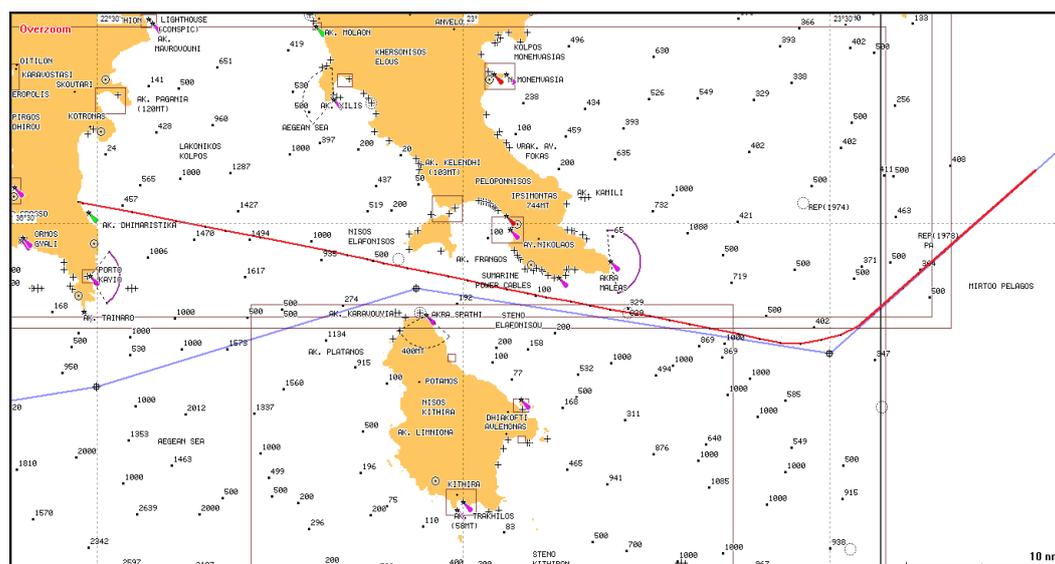
On the 7th of June 2017, at approximately 05:13 (L.T.), the B/C St. Gregory grounded on the rocky coastline at the South Coast of Peloponnese (Kokkala - Greece), in position lat: 36° 31’ 40” N, long:022° 28’ 29” E, after passing W.P. No.9 without altering her course. At the time of the marine casualty, weather conditions were reported to be with very good visibility, wind force ENE 5-6 bfrs, sea was moderate and it was still dark. None of the crew was injured and no pollution was reported.

Figure 1: The actual course of ST GREGORY (red line) until her grounding, in relation to the planned route (blue line)

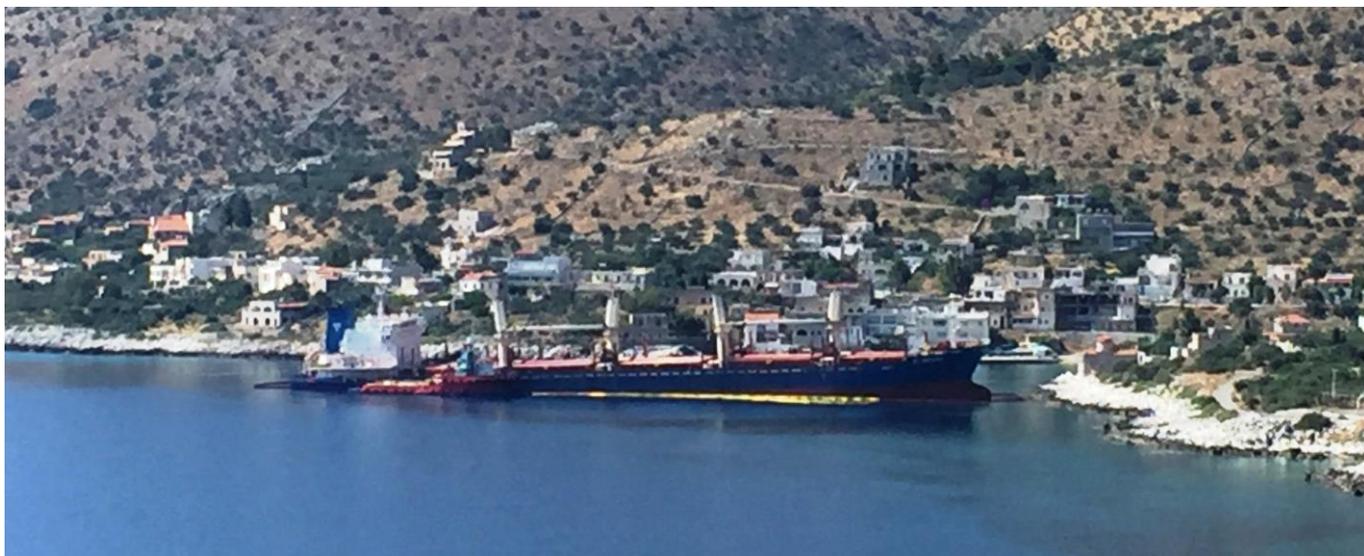
St. Gregory grounded on a bottom of sand and rocks by bow up to frame number 180. As a result of the grounding, there was damage to the hull with several dents and cracks near the bulkhead between the FPTK and WBT 1SB. More specifically there were 29 cracks observed in the WBT 1P & 1S, the FPTK and the Pipetunnel.

Figure 2: ST. GREGORY aground at Kokkala

St. Gregory re-floated on 20th June 2017, after off loading of her cargo and anchored with the assistance of two (02) Salvage Tugs, at Gytheio anchorage sea area. On 6th of September 2017 St. Gregory was escorted by a Salvage Tug to Chalkis Shipyard, Greece, in order to undergo permanent repairs.
