SAFETY RECOMMENDATION No: 01/2018

01/2018: Parting of a mooring rope of M/T "BYZANTION", flag GREECE, IMO 9315898 during unmooring operation resulting to the death of an O/S, Philippine nationality at Dortyol, Turkey on 7th June 2018

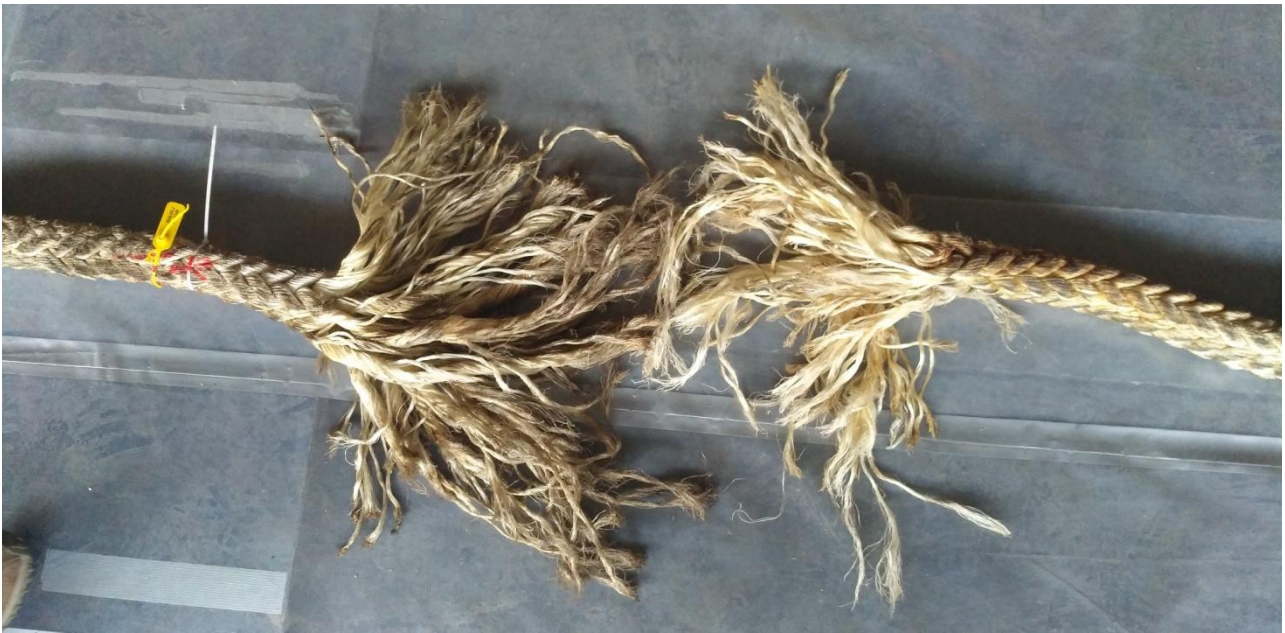
Figure2: The rope's breaking point at the part that remained onboard (left part of the photo) and at the part that remained on the terminal's bollard (right part of the photo).

5. The parted mooring rope's physical and mechanical properties were found to be significantly inferior to the ones expected according to the document presented as its "Test Certificate". The fact that at the Tensile Test the rope parted at a load of 33.96 tn in laboratory circumstances, suggests that the breaking load of that rope under dynamically acting forces would be significantly

reduced. This parameter is explanatory of the non-function of BYZANTION's Mooring Winch Brake rendering, as the examined mooring rope, due to its dynamic loading, probably broke prior to its loading up to 30.6 tn, which was the Mooring Winch Brake limit.
