SAFETY RECOMMENDATION No: 02/2012

01/2012: Fire on board Ro-Pax "KRITI II"
(See the full Report [here.](#))

Fire inside the garage space of Ro-Pax

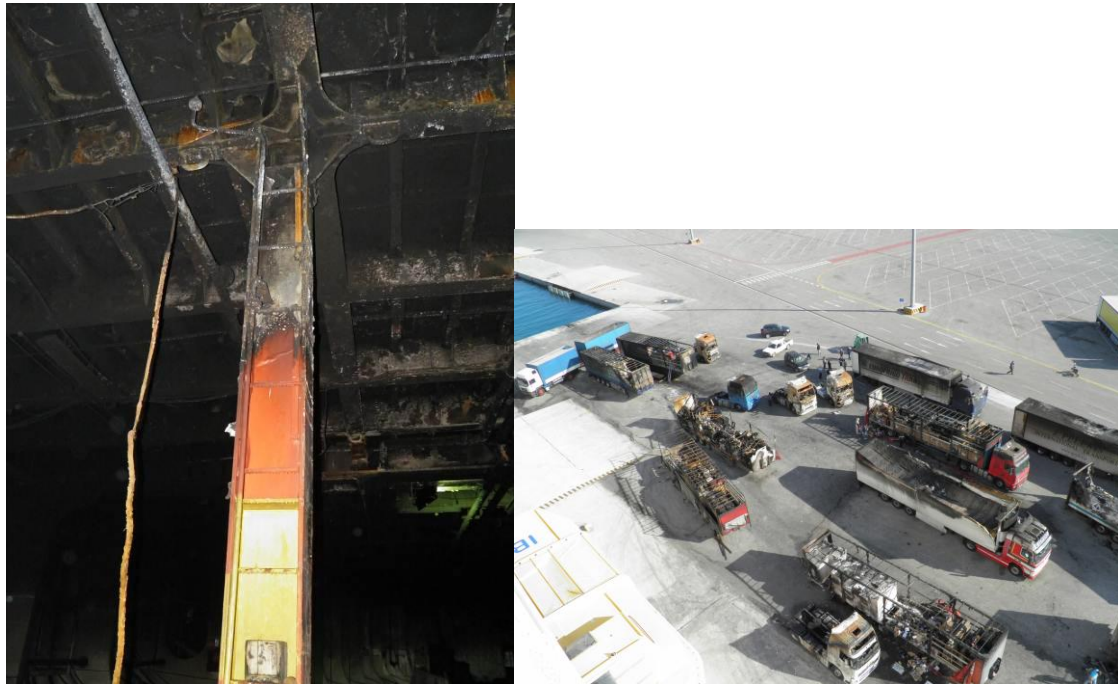
Photos of the damages on the top of the garage and trucks

The consequences of the examined accident were confined to a limited damage to the ship and extensive damage to trucks which were in the vicinity of the seat of the fire in the main garage.
