## SAFETY RECOMMENDATION No: 02/2013

01/2013: Loss of life of seaman after falling overboard passenger launch boat "Vaggelio".

### **Loss of life of seaman after falling overboard passenger launch boat**

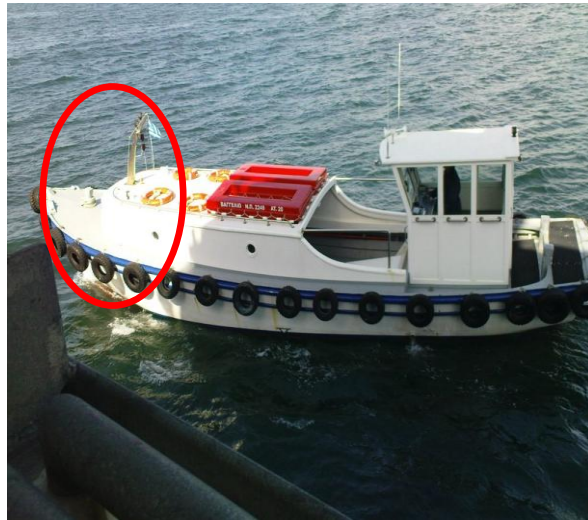
**Picture 1:** The launch boat. The point of embarkation of the three persons from the tanker has been highlighted (red ellipse).

The disembarkation of persons from the tanker was carried out with the ship traveling with very low speed, about a knot, so the launch approached the ship with her bow and left cheek (mask) maintaining a speed equal to that of the ship. Also, the delivery and collection of baggage was carried out at the bow of the launch.

Therefore, the prescribed procedure in accordance with number 6 Command - Directive of the launch's General Inspection Protocol, noting that "Under the responsibility of the skipper, it is not allowed to passengers to stay and pass in places other than the aft passenger deck", was not followed.

Also, the prevailing weather conditions, winds southeasterly with force of 6 Bfs, and the rolling of the launch because of undulation, contributed in the creation of precarious conditions for the procedure as followed, so this can be considered as one of the factors of loss of balance and consequent fall of the seaman in the sea.

The launches' companies should make clear to the skippers that baggage or any other equipment collection should be considered as separate procedure from the embarkation of the passengers and therefore should be carried out as long as the weather conditions aloud in turns of crew and passengers safety.

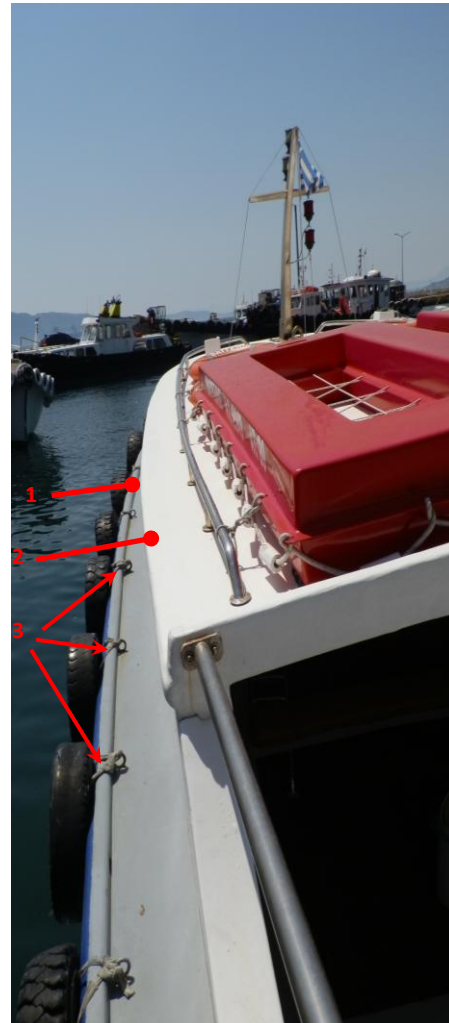
**Picture 2:** View from the stern of the left side deck of passenger launch. They are distinguished:

1. Handrail of board
2. Prominence of the superstructure
3. Pegs tire suspension
