## SAFETY RECOMMENDATION No: 01/2017

01/2017: Grounding of B/C “St. Gregory”  
(See the full Report [here.](#))

### Grounding of B/C “St. Gregory”

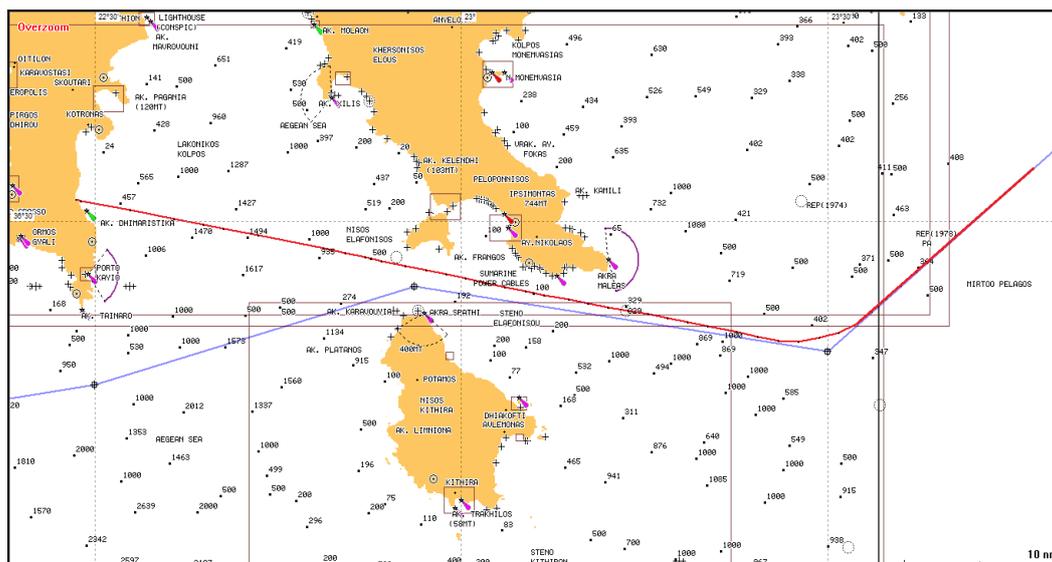
On the 7th of June 2017, at approximately 05:13 (L.T.), the B/C St. Gregory grounded on the rocky coastline at the South Coast of Peloponnese (Kokkala - Greece), in position lat: 36° 31’ 40” N, long:022° 28’ 29” E, after passing W.P.No.9 without altering her course. At the time of the marine casualty, weather conditions were reported to be with very good visibility, wind force ENE 5-6 bfrs, sea was moderate and it was still dark. None of the crew was injured and no pollution was reported.

**Figure 1:** The actual course of ST GREGORY (red line) until her grounding, in relation to the planned route (blue line)

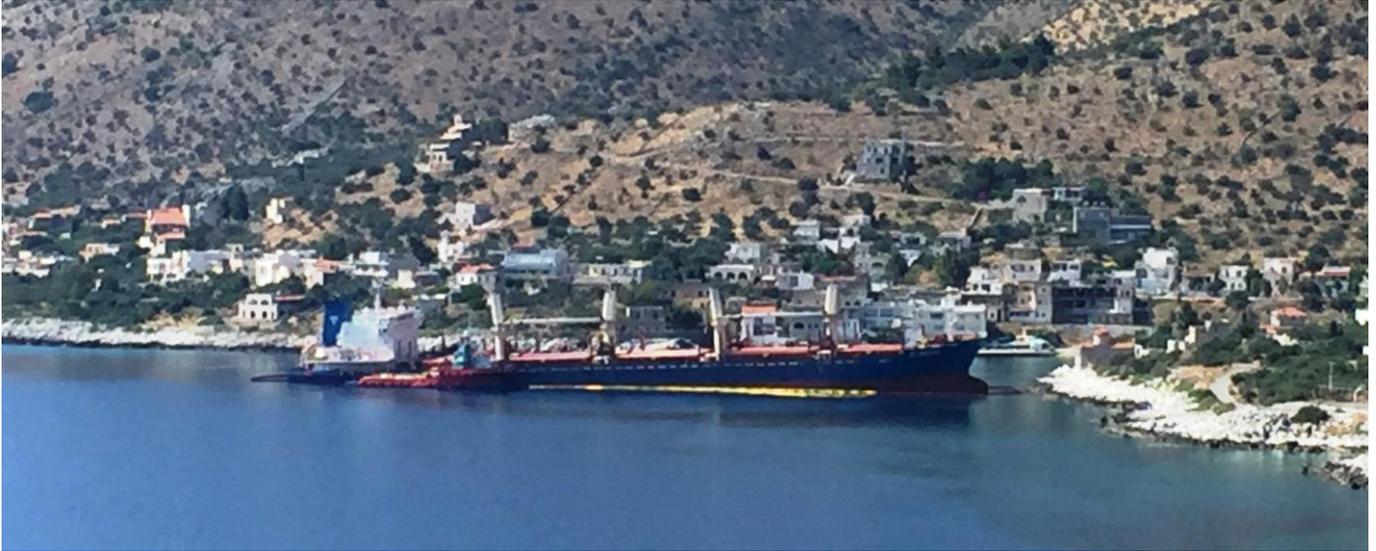
St. Gregory grounded on a bottom of sand and rocks by bow up to frame number 180. As a result of the grounding, there was damage to the hull with several dents and cracks near the bulkhead between the FPTK and WBT 1SB. More specifically there were 29 cracks observed in the WBT 1P & 1S, the FPTK and the Pipetunnel.

**Figure 2:** ST. GREGORY aground at Kokkala

St. Gregory re-floated on 20th June 2017, after off loading of her cargo and anchored with the assistance of two (02) Salvage Tugs, at Gytheio anchorage sea area. On 6th of September 2017 St. Gregory was escorted by a Salvage Tug to Chalkis Shipyard, Greece, in order to undergo permanent repairs.
