SAFETY RECOMMENDATION No: 03/2013

01/2013: Loss of life of seaman after falling overboard passenger launch boat "Vaggelio".
(See the full Report [here.](#))

Type of vessel: Passenger launch boat

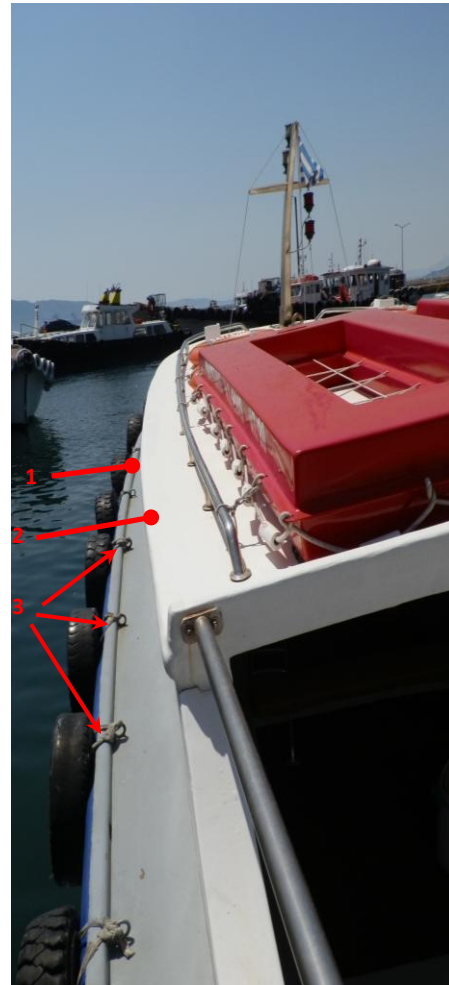
Picture 2: View from the stern of the left side deck of passenger launch. They are distinguished:

1. Handrail of board
2. Prominence of the superstructure
3. Pegs tire suspension
