SAFETY RECOMMENDATION No: 03/2014

No of Safety Investigation Report: 01/2014: Grounding and Foundering of F/V "AGIA MARINA" Registry of Mytilene no. 363
(See the full Report [here.](#))

Grounding and Foundering of F/V "AGIA MARINA", Registry of Mytilene no. 363

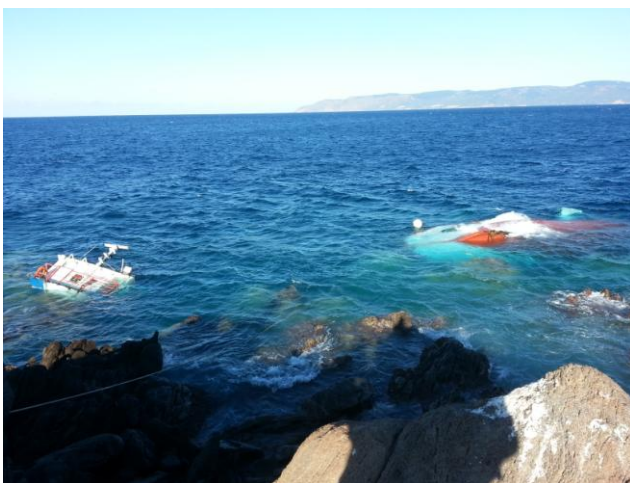
AGIA MARINA remained at the grounding spot and due to the sea conditions she sustained multiple breaches and was foundered the following day. Only few parts of her equipment were recovered, whereas all documents, including the Bridge Log Book were lost.

Photos from the vessel's total loss due to the sea conditions and the rocky coast and from her equipment parts which were recovered a few days after the accident.

A malfunction of the steering mechanism took place leading to the rudder's immobilization and the inability of its control from the bridge area. The Captain lost the navigation control and the vessel maintaining a course toward the rocky coast grounded shortly with her port bow against cape "Kseres".

It is recommended that a 48-month maintenance schedule regarding the overhauling of all electromechanical parts of the fishing vessels equipment should be set up, taking into consideration the manufacturers' maintenance manuals.
