SAFETY RECOMMENDATION No: 04/2012

No of Safety Investigation Report:	01/2012: Fire on board Ro-Pax "KRITI II" (See the full Report here .)
---	--

Fire inside the garage space of Ro-Pax

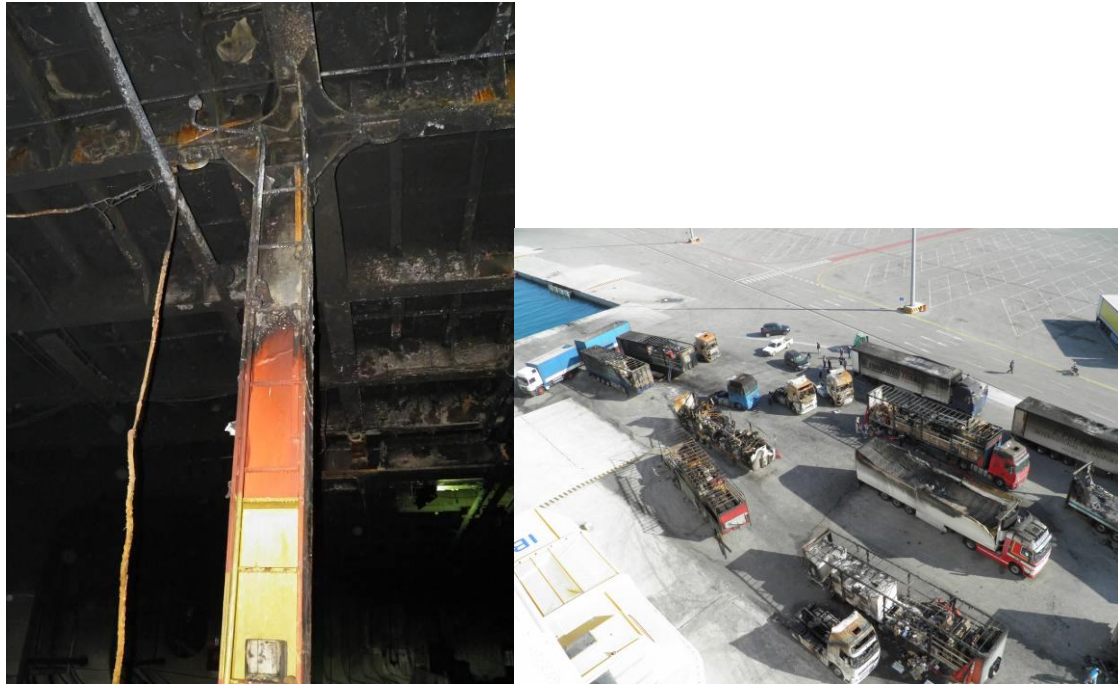
Photos of the damages on the top of the garage and trucks

The consequences of the examined accident were confined to a limited damage to the ship and extensive damage to trucks which were in the vicinity of the seat of the fire in the main garage.

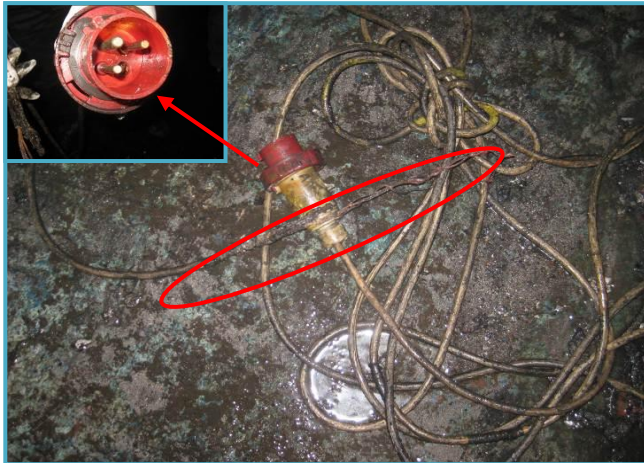
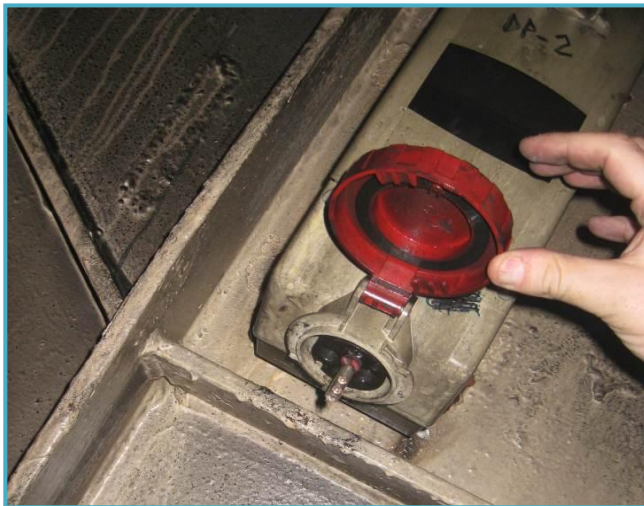
The cable extension (extension cord), that was connected to a refrigerator truck and which is rated as one of the possible fire ignition points. The damaged side of the cable that ended at the refrigerated truck is shown and the plug which was connected to the socket DP2.

Additionally, in some extension cables were observed alterations that were potentially the result of a short-circuit. Also, the extension cable used for the connection of the refrigerator which is considered to be one of the possible points of ignition of the fire, presented wear in a lot of points which had been covered with insulating tape.

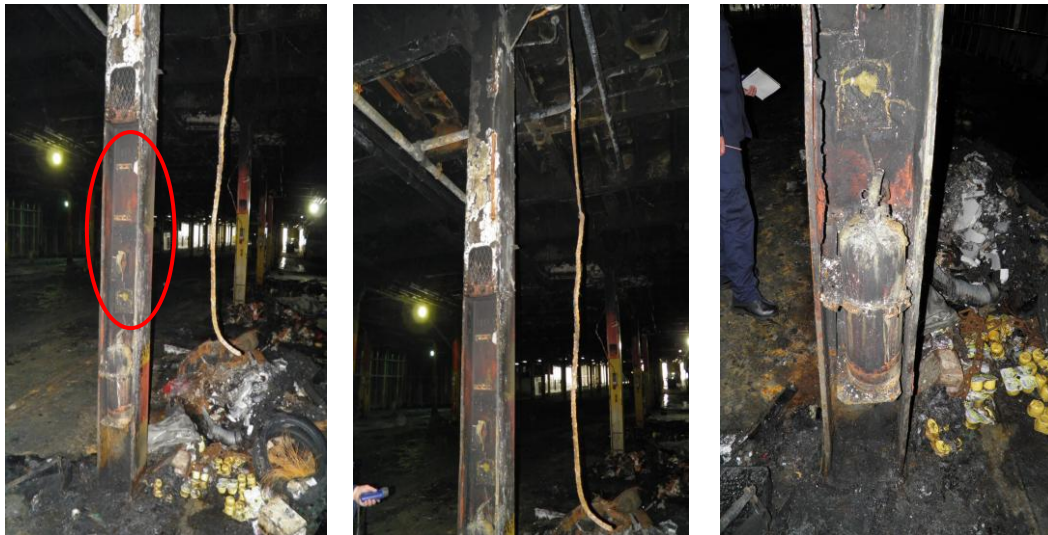
According to the collected data during the technical investigation, although documented monthly reports of the resistances of the electrical installation's equipment by performing tests with the Megger device (Megger Test) by the Chief Electrician and the ship's Electrical Sector's personnel were satisfactory, however, a number of sockets were found with residues of sockets' terminals at the connection points, which were the result of the development of an electric arc due to their bad connection.

The pillar between frames 219-221, which was found with increased fire indicators in its fore side, the base of the socket and the cut cable. Also fusion signs of the socket material are evident on the fire extinguisher and the deck.

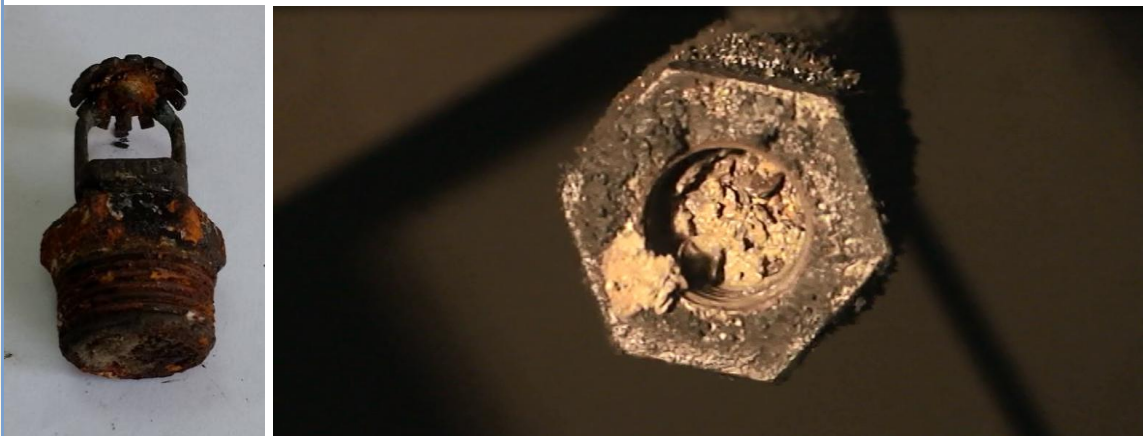
In regard to the fire fighting it is pointed out that the fire broke out at a time of an unexecuted fire patrol. Also the permanent Drencher system which was the only firefighting means while the ship was at sea, since the approach of the fire by the Risk Response Team was not feasible; two out of three heads of the Drencher system were found clogged after the fire extinguishment.

Clogged head and pipe of "DRENCHER" system

Finally it is noted that the parallel operation of several zones of the Drencher system, namely the activation of additional zones for cooling, may have affected its performance at the fire area as there is no technical guidance for the maximum number of drencher zones in parallel operation with respect to the required performance of the permanent Drencher system.

Conducting "Targeted Action Plan» to assess the measures and provided directives offered by 24-01-2013 Circular ΥΝΑ/ΚΕΕΠ/ΔΜΚ/ΠΥΡΦ4231/07/2013 for the maintenance and periodical inspection of Drencher systems which is included in the field of application of Resolution 123 of the 5th session of the International Maritime Organization on October 25, 1967.
