## SAFETY RECOMMENDATION No: 04/2013

01/2013: Loss of life of seaman after falling overboard passenger launch boat "Vaggelio".

### **Loss of life of seaman after falling overboard passenger launch boat**

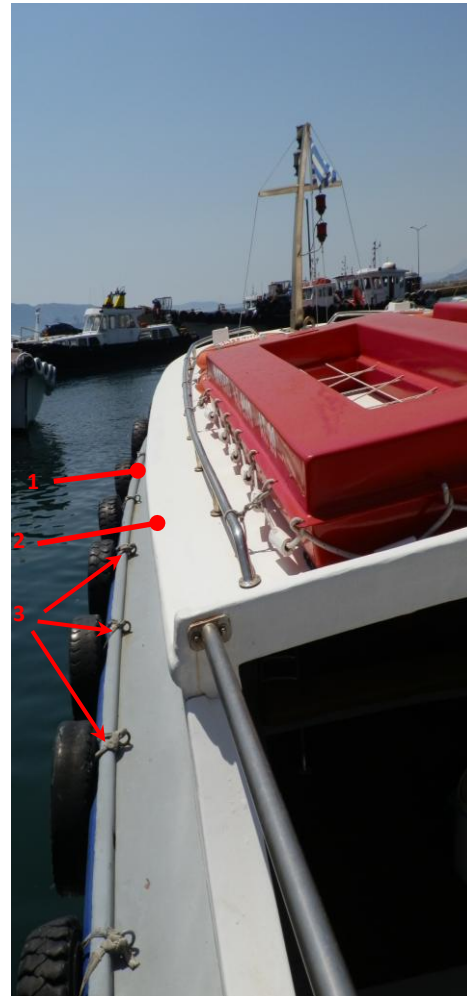
**Picture 2:** View from the stern of the left side deck of passenger launch. They are distinguished:

1. Handrail of board
2. Prominence of the superstructure
3. Pegs tire suspension
