SAFETY RECOMMENDATION No: 06/2012

01/2012: Fire on board Ro-Pax "KRITI II"
(See the full Report [here.](#))

Fire inside the garage space of Ro-Pax

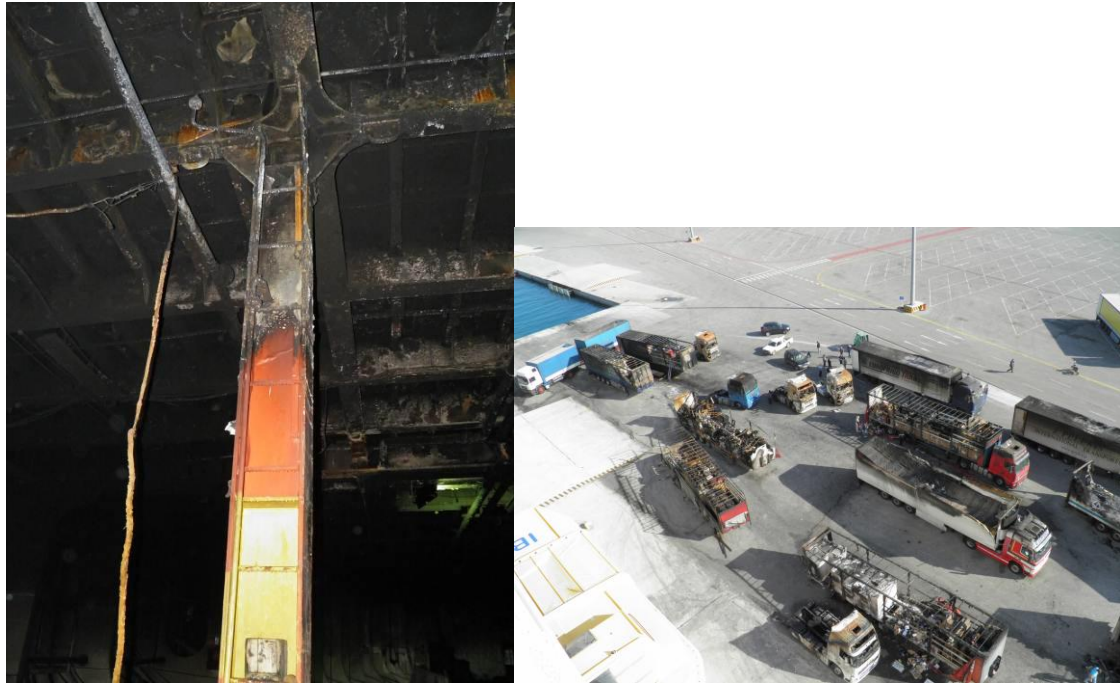
Photos of the damages on the top of the garage and trucks

The consequences of the examined accident were confined to a limited damage to the ship and extensive damage to trucks which were in the vicinity of the seat of the fire in the main garage.
