SAFETY RECOMMENDATION No: 06/2013

01/2013: Loss of life of seaman after falling overboard passenger launch boat "Vaggelio".
(See the full Report [here.](#))

Loss of life of seaman after falling overboard passenger launch boat

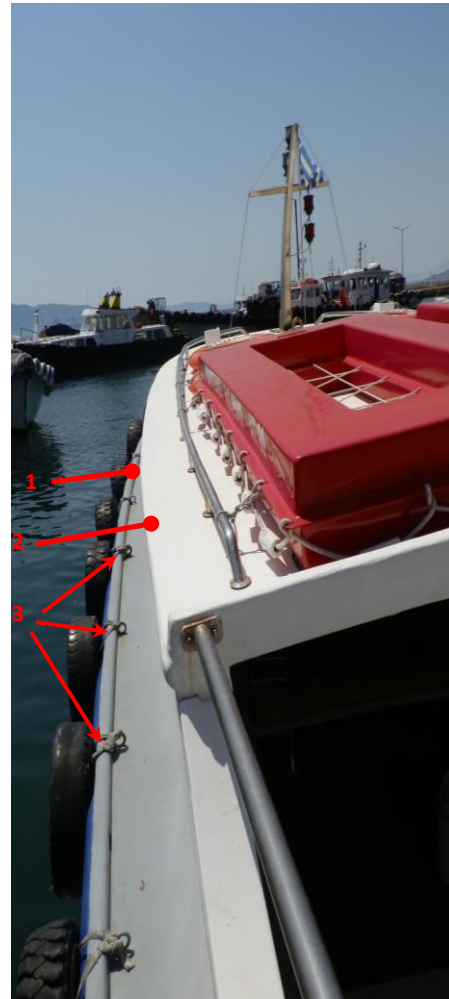
Picture 2: View from the stern of the left side deck of passenger launch. They are distinguished:

1. Handrail of board
2. Prominence of the superstructure
3. Pegs tire suspension
