SAFETY RECOMMENDATION No: 07/2013

01/2013: Loss of life of seaman after falling overboard passenger launch boat "Vaggelio".

Loss of life of seaman after falling overboard passenger launch boat

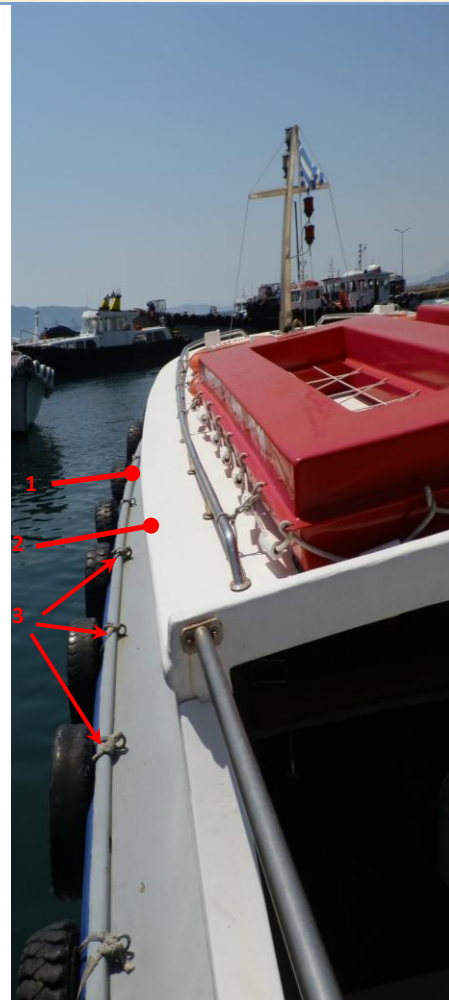
Picture 2: View from the stern of the left side deck of passenger launch. They are distinguished:

1. Handrail of board
2. Prominence of the superstructure
3. Pegs tire suspension
