## SAFETY RECOMMENDATION No: 08/2013

01/2013: Loss of life of seaman after falling overboard passenger launch boat "Vaggelio".

### **Loss of life of seaman after falling overboard passenger launch boat**

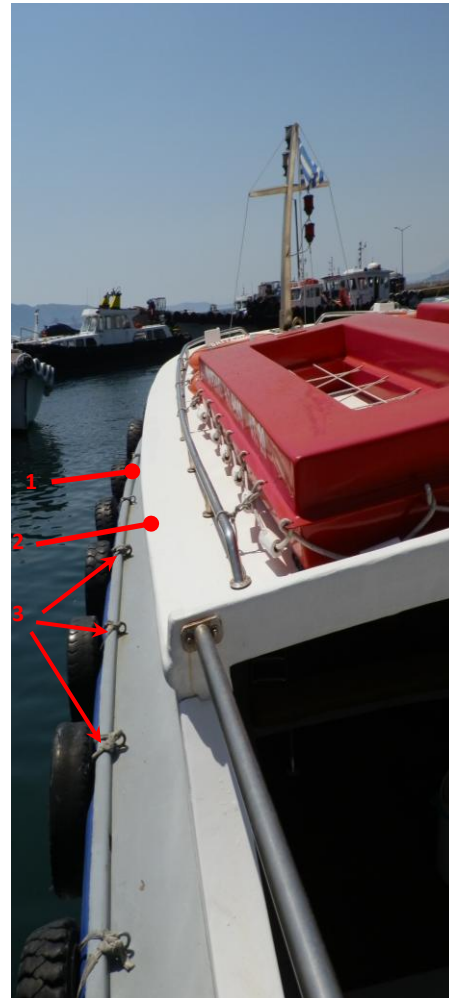
**Picture 2:** View from the stern of the left side deck of passenger launch. They are distinguished:

1. Handrail of board
2. Prominence of the superstructure
3. Pegs tire suspension
