SAFETY RECOMMENDATION No: 08/2014

No of Safety Investigation Report: 01/2014: Grounding and Foundering of F/V "AGIA MARINA" Registry of Mytilene no. 363
(See the full Report [here.](#))

Grounding and Foundering of F/V "AGIA MARINA", Registry of Mytilene no. 363

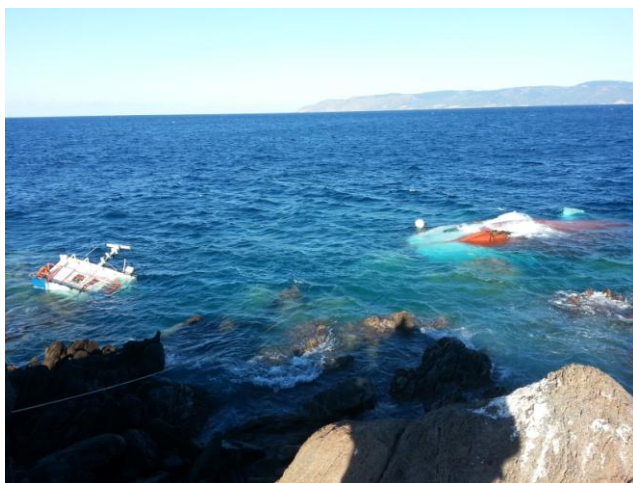
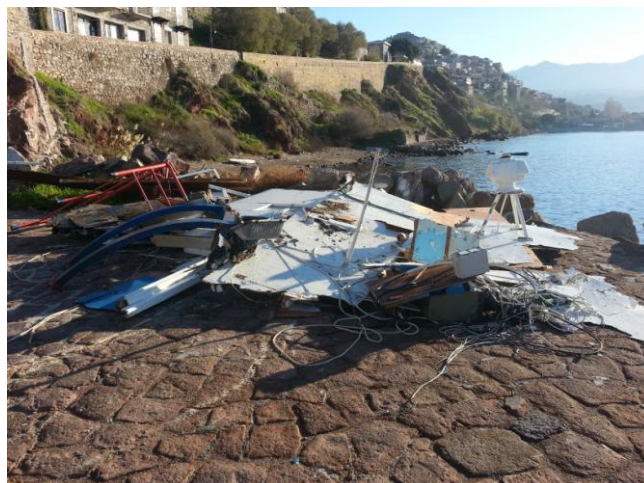
AGIA MARINA remained at the grounding spot and due to the sea conditions she sustained multiple breaches and was foundered the following day. Only few parts of her equipment were recovered, whereas all documents, including the Bridge Log Book were lost.

Photos from the vessel's total loss due to the sea conditions and the rocky coast and from her equipment parts which were recovered a few days after the accident.
