SAFETY RECOMMENDATION No: 09/2012

01/2012: Fire on board Ro-Pax "KRITI II"
(See the full Report [here.](#))

Fire inside the garage space of Ro-Pax

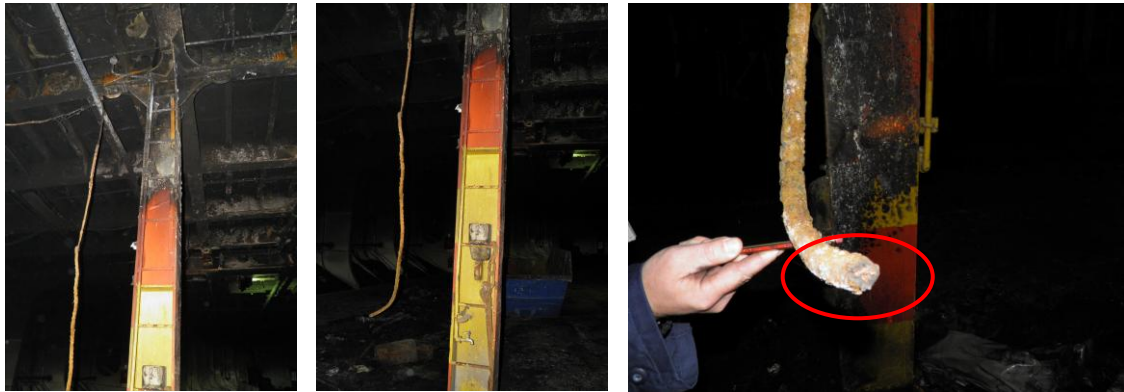
The aft side of the pillar, between frames 219-221, and the cut cable.
