## SAFETY RECOMMENDATION No: 09/2013

01/2013: Loss of life of seaman after falling overboard passenger launch boat "Vaggelio".  
*(See the full Report [here.](#))*

### **Loss of life of seaman after falling overboard passenger launch boat**

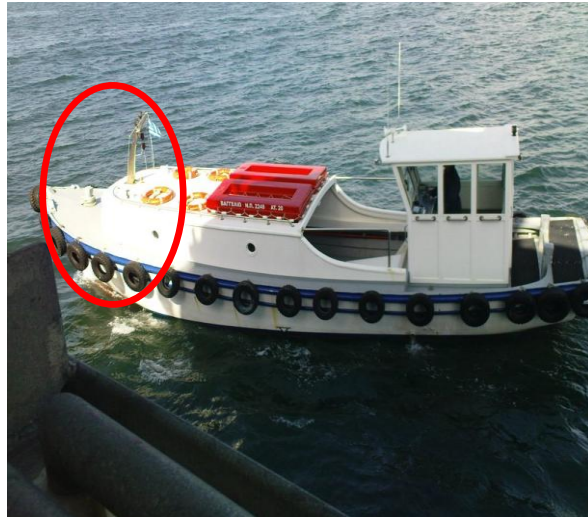
The embarkation took place on the left bow side of launch. Initially, they boarded in the bow of launch, first the motorman, then the pilot and finally the cook of the tanker. The last one received from a member of the crew of the tanker a bag with his personal items and a suitcase with the vessel's documents and in his effort to move with the baggage at the stern of the launch, he lost his balance and fell in the sea.

**Picture 1:** The launch boat. The point of embarkation of the three persons from the tanker has been highlighted (red ellipse).

The disembarkation of persons from the tanker was carried out with the ship traveling with very low speed, about a knot, so the launch approached the ship with her bow and left cheek (mask) maintaining a speed equal to that of the ship. Also, the delivery and collection of baggage was carried out at the bow of the launch.

Therefore, the prescribed procedure in accordance with number 6 Command - Directive of the launch's General Inspection Protocol, noting that "Under the responsibility of the skipper, it is not allowed to passengers to stay and pass in places other than the aft passenger deck", was not followed.

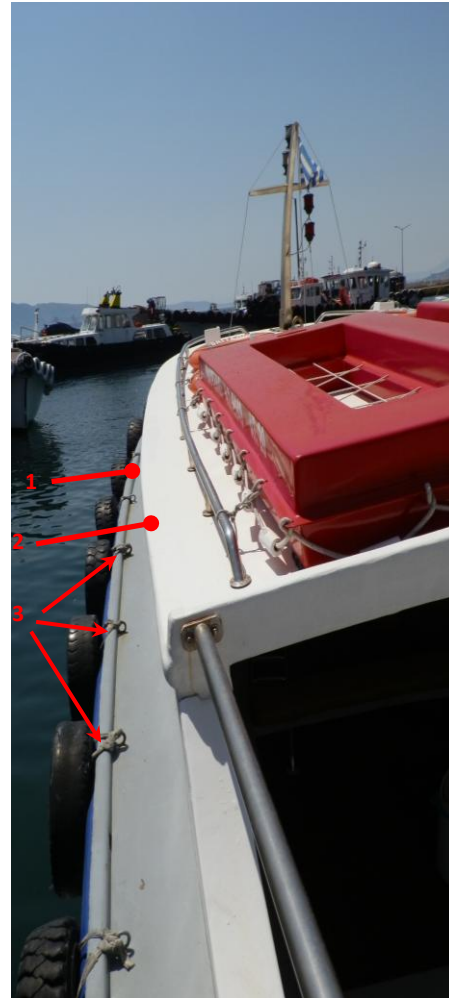
**Picture 2:** View from the stern of the left side deck of passenger launch. They are distinguished:

1. Handrail of board
2. Prominence of the superstructure
3. Pegs tire suspension
