## SAFETY RECOMMENDATION No: 09/2014

<b>No of Safety Investigation Report:</b>	01/2014: Grounding and Foundering of F/V "AGIA MARINA" Registry of Mytilene no. 363 <i>(See the full Report <a href="#">here.</a>)</i>
<b>Safety Recommendation addressed to:</b>	Ships' Design and Constuction Directorate
<b>Date of publication:</b>	21/12/2015

### **Grounding and Foundering of F/V "AGIA MARINA", Registry of Mytilene no. 363**

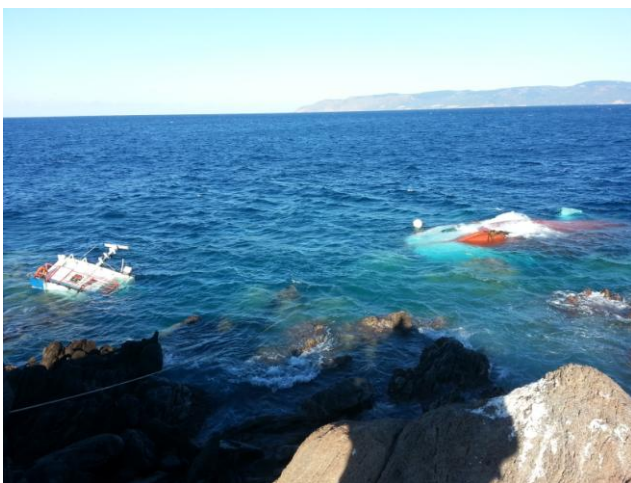
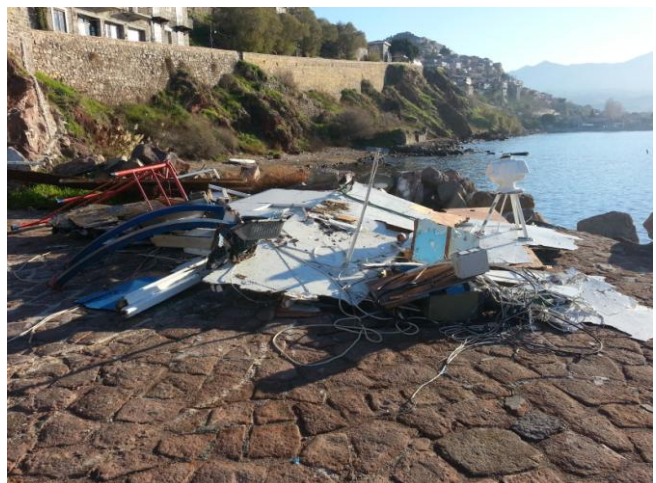
AGIA MARINA remained at the grounding spot and due to the sea conditions she sustained multiple breaches and was foundered the following day. Only few parts of her equipment were recovered, whereas all documents, including the Bridge Log Book were lost.

Photos from the vessel's total loss due to the sea conditions and the rocky coast and from her equipment parts which were recovered a few days after the accident.
