SAFETY RECOMMENDATION No: 10/2013

No of Safety Investigation Report:	02/2013: Injury of seaman on board Ro-Pax "NISOS KEFALONIA". <i>(See the full Report here.)</i>
---	--

Injury of seaman on board Ro-Pax

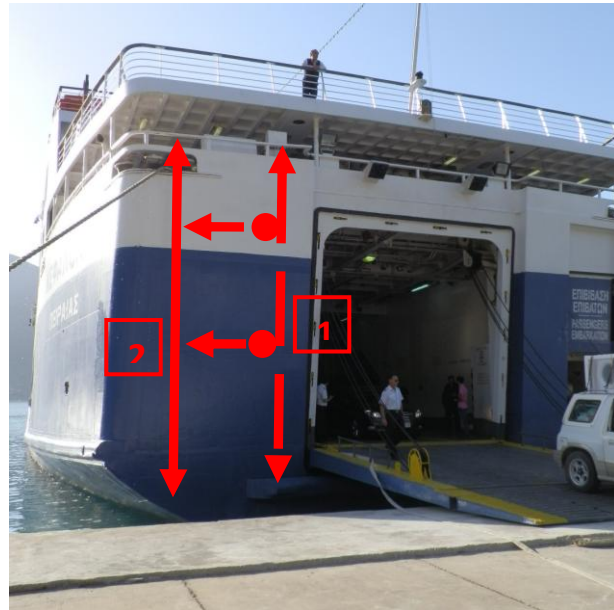
ship was asked to move the rope of suspension of a rubber pad («fender») which protects the left aft girde of the ship against contact with the pier. In his effort, the seaman was injured on his left thumb, and was directly transferred to the local hospital where he received medical treatment and hospitalization.

Picture 1: The initial (position 1) and final position (position 2) of the suspension of the rubber pad.

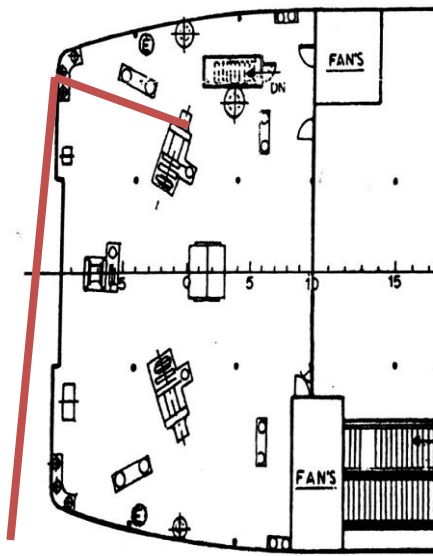
In addition, the morphology of the port did not ensure sufficient protection for moored ships when adverse weather conditions prevailed due to the large surface of exposure of the vessels to the strong winds from south directions, which created large torques. Also, the depth of the port is not sufficient to ensure the approach of ships and the laying of anchors, so the securing of the ship was achieved with use of additional ropes from the bow (springs).

Picture 2: Layout scheme of the aft mooring deck with the additional rope that was placed to hold the stern against the influence of the southern wind

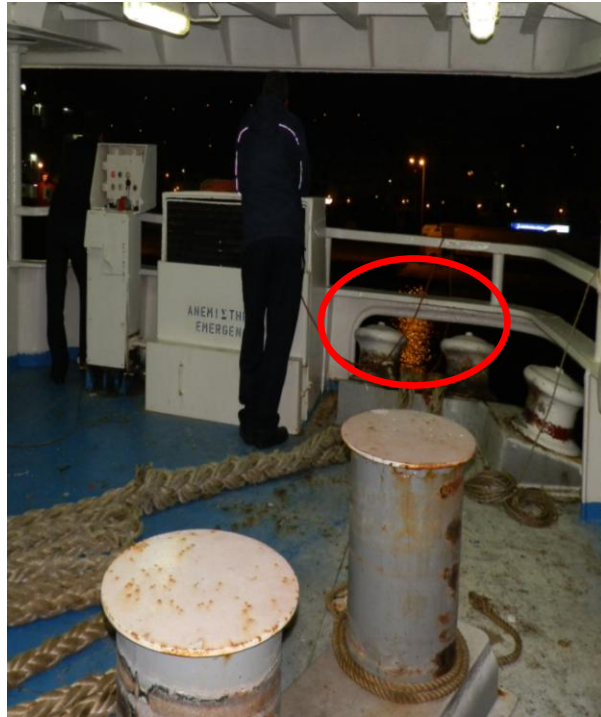
Before the mooring of ship, risk assessment process according to Safety Management Code (ISM Code - Chapter IX SOLAS 74) was not carried out, in order to detect any risk factors under the prevailing adverse weather conditions and develop any appropriate measures for safe mooring of the ship as well as any additional measures to protect personnel. It is noted that the powerful lateral winds with blasts of very powerful force created dynamically alterable tensions to the mooring ropes, resulting in the light traverse locomotion of the ship and causing small locomotion of ropes in the fairlead rollers from which they passed.

Picture 3: View of the left aft mooring deck space. Marked (circled in red color) the fairlead rollers through which the stern ropes passed which was the point where the seaman got injured.

In the examined marine accident, the aforementioned factors were not adequately evaluated; as a result the action of the seaman to get his hand between the rope and the roller in order to hold the suspension line of rubber pad, led to his injury.

Re-evaluation of the risk assessment procedure concerning the mooring operation of the ship, from the management companies of the ships, especially under bad weather conditions, aiming in finding out any unsafe factors and points of high risk in order to take necessary measures.
