SAFETY RECOMMENDATION No: 11/2012

No of Safety Investigation Report:	01/2012: Fire on board Ro-Pax "KRITI II" (See the full Report here.)
Safety Recommendation addressed to:	Owner and Management Company of Ro-Pax "KRITI II"
Date of publication:	19/11/2014

Fire inside the garage space of Ro-Pax

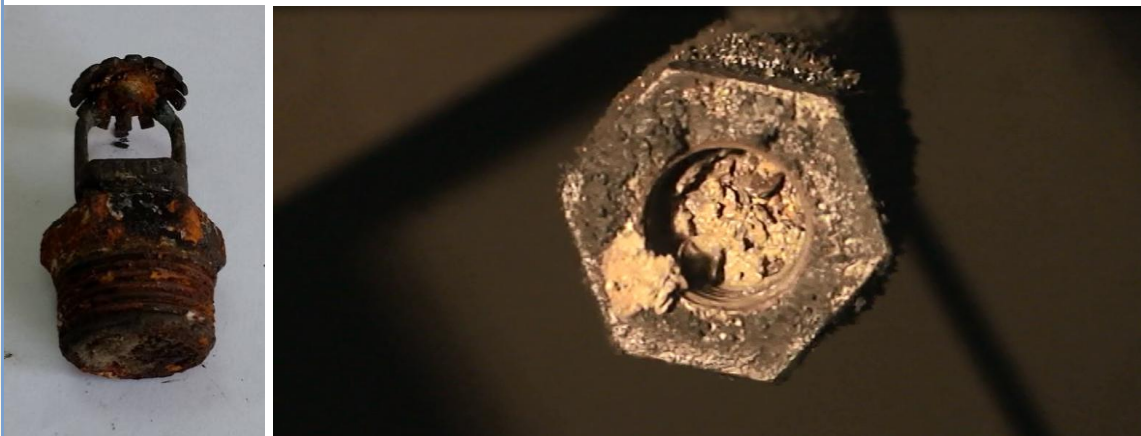
In regard to the fire fighting it is pointed out that the fire broke out at a time of an unexecuted fire patrol. Also the permanent Drencher system which was the only firefighting means while the ship was at sea, since the approach of the fire by the Risk Response Team was not feasible; two out of three heads of the Drencher system were found clogged after the fire extinguishment.

Clogged head and pipe of "DRENCHER" system

Finally it is noted that the parallel operation of several zones of the Drencher system, namely the activation of additional zones for cooling, may have affected its performance at the fire area as there is no technical guidance for the maximum number of drencher zones in parallel operation with respect to the required performance of the permanent Drencher system.
