SAFETY RECOMMENDATION No: 11/2013

No of Safety Investigation Report:	02/2013: Injury of seaman on board Ro-Pax "NISOS KEFALONIA". <i>(See the full Report here.)</i>
---	--

Injury of seaman on board Ro-Pax

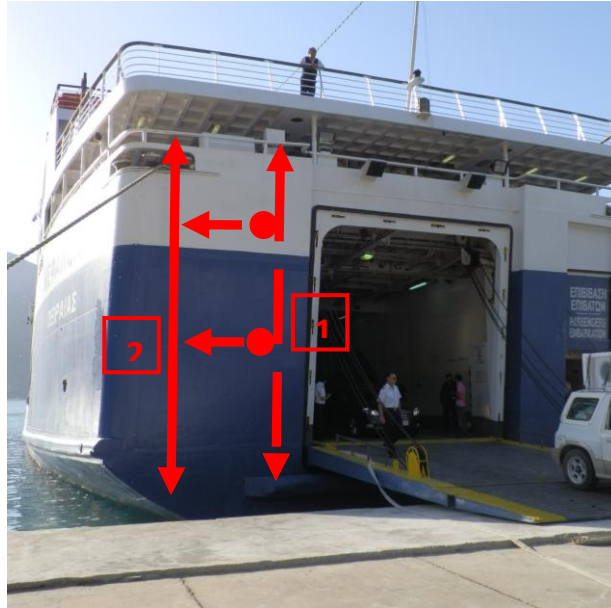
with ropes mainly from the bow ("springs"). One of the seamen on duty at the stern of the ship was asked to move the rope of suspension of a rubber pad («fender») which protects the left aft girde of the ship against contact with the pier. In his effort, the seaman was injured on his left thumb, and was directly transferred to the local hospital where he received medical treatment and hospitalization.

Picture 1: The initial (position 1) and final position (position 2) of the suspension of the rubber pad.

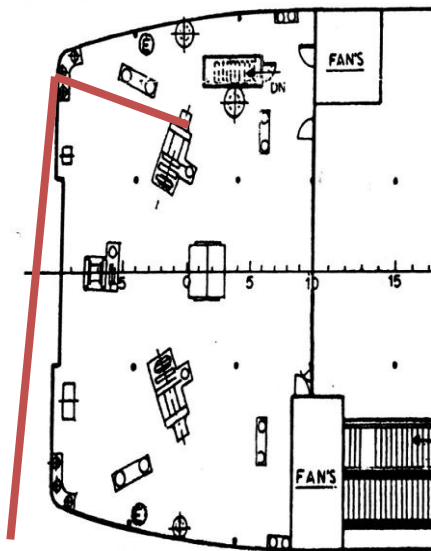
In addition, the morphology of the port did not ensure sufficient protection for moored ships when adverse weather conditions prevailed due to the large surface of exposure of the vessels to the strong winds from south directions, which created large torques. Also, the depth of the port is not sufficient to ensure the approach of ships and the laying of anchors, so the securing of the ship was achieved with use of additional ropes from the bow (springs).

Picture 2: Layout scheme of the aft mooring deck with the additional rope that was placed to hold the stern against the influence of the southern wind
