SAFETY RECOMMENDATION No: 11/2014

| No of Safety Investigation Report: | 02/2014: Grounding of B/C "INCE INEBOLU" (See the full Report here.) |

Grounding of B/C "INCE INEBOLU"

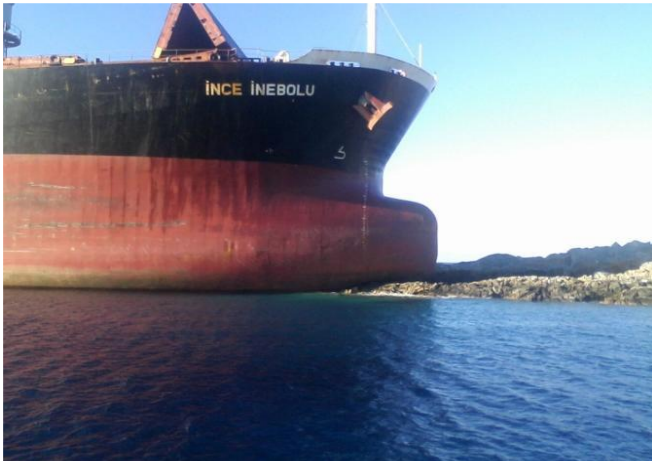
Grounding point of Ince Inebolu at Astypalaia Island.

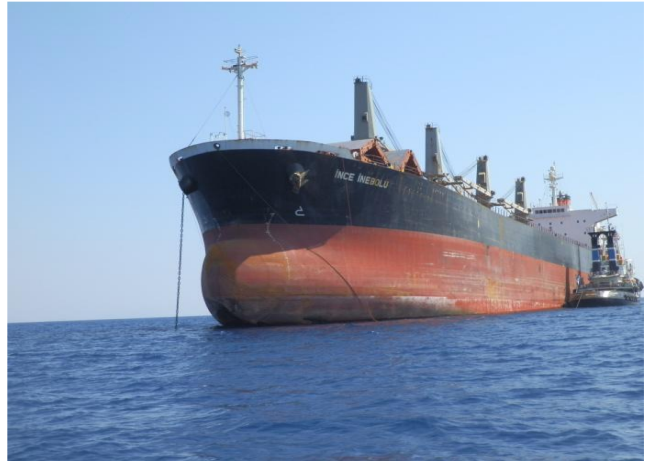
Ince Inebolu anchored at Astypalaia.

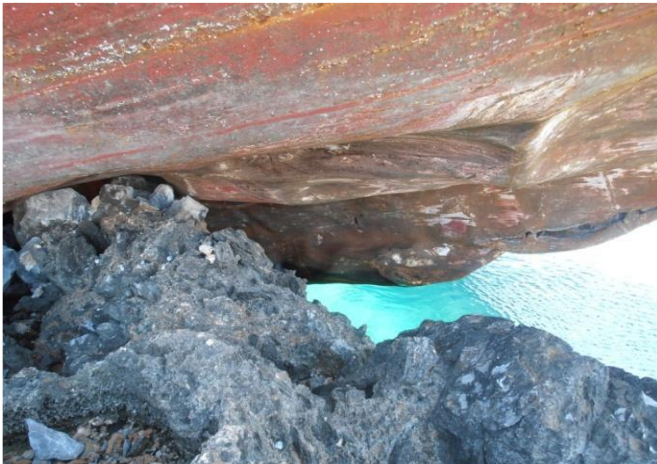
Due to the heavy impact on the rocky coastline, several compartments of Ince Inebolu bow section were damaged to an extent of about 21 m of length longitudinally. More specific the damages reported to be cracks and hull plating deformation at forepeak tank, collision bulkhead, No. 1 cargo Hold, No 1 port and starboard ballast tanks. No injuries and no pollution was reported.

Deformed starboard bottom fore section.

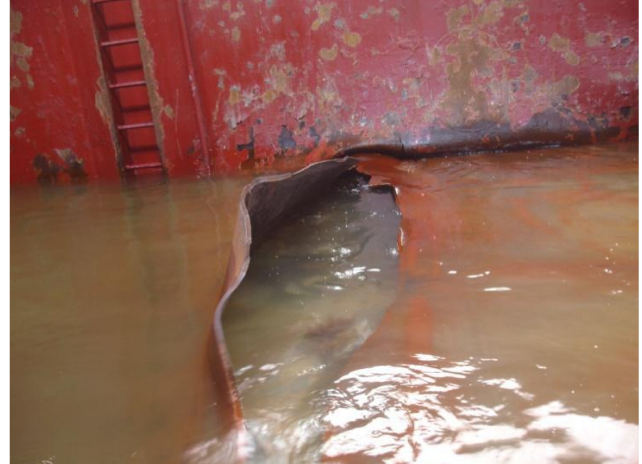
The crack at inner bottom plate of No 1 cargo hold.
