SAFETY RECOMMENDATION No: 11/2015

03/2015: Death by asphyxiation of the Bosun of Bulk Carrier KOSMAS V, Panama Flag, IMO 9445681, after entering a cargo hold

04/10/2016

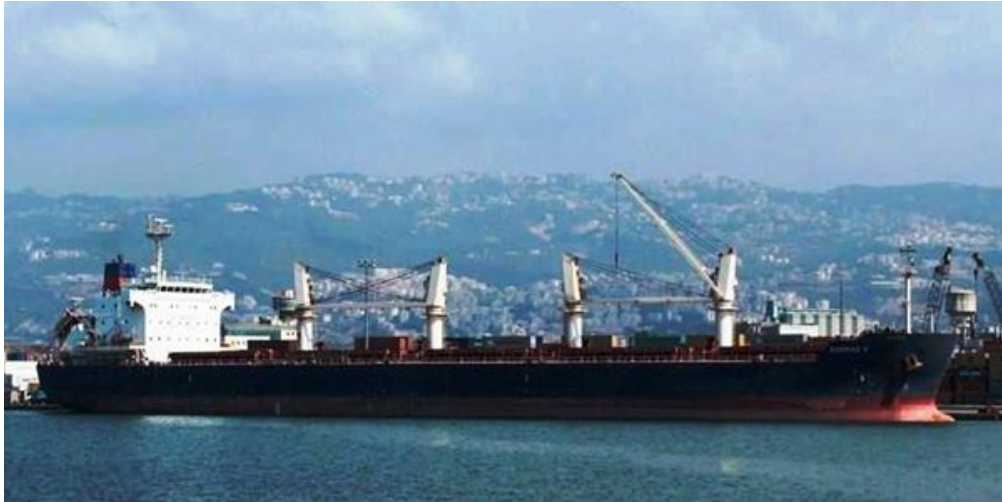
Bulk carrier KOSMAS V.
