## SAFETY RECOMMENDATION No: 12/2013

02/2013: Injury of seaman on board Ro-Pax  
"NISOS KEFALONIA".  
(See the full Report [here.](#))

### **Injury of seaman on board Ro-Pax**

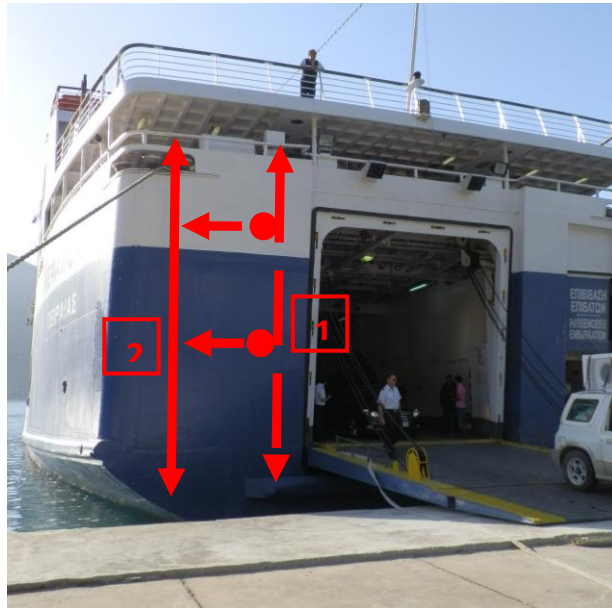
**Picture 1:** The initial (position 1) and final position (position 2) of the suspension of the rubber pad.

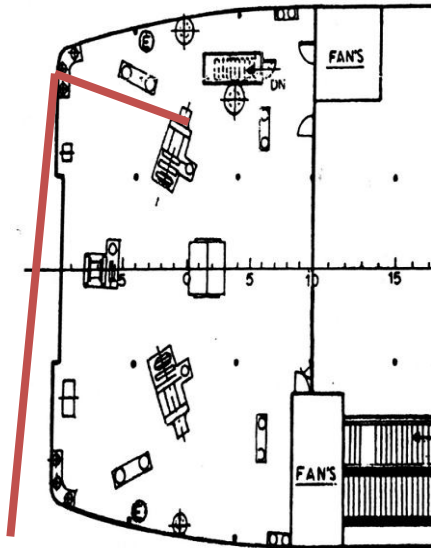
In addition, the morphology of the port did not ensure sufficient protection for moored ships when adverse weather conditions prevailed due to the large surface of exposure of the vessels to the strong winds from south directions, which created large torques. Also, the depth of the port is not sufficient to ensure the approach of ships and the laying of anchors, so the securing of the ship was achieved with use of additional ropes from the bow (springs).

**Picture 2:** Layout scheme of the aft mooring deck with the additional rope that was placed to hold the stern against the influence of the southern wind

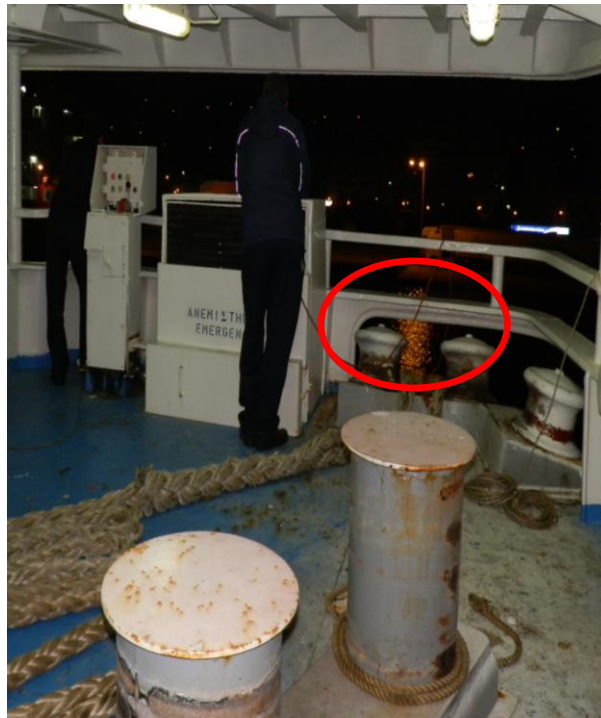
Before the mooring of ship, risk assessment process according to Safety Management Code (ISM Code - Chapter IX SOLAS 74) was not carried out, in order to detect any risk factors under the prevailing adverse weather conditions and develop any appropriate measures for safe mooring of the ship as well as any additional measures to protect personnel. It is noted that the powerful lateral winds with blasts of very powerful force created dynamically alterable tensions to the mooring ropes, resulting in the light traverse locomotion of the ship and causing small locomotion of ropes in the fairlead rollers from which they passed.

**Picture 3:** View of the left aft mooring deck space. Marked (circled in red color) the fairlead rollers through which the stern ropes passed which was the point where the seaman got injured.

In the examined marine accident, the aforementioned factors were not adequately evaluated; as a result the action of the seaman to get his hand between the rope and the roller in order to hold the suspension line of rubber pad, led to his injury.

Evaluation, from the managing authorities of the ports, of the necessity to perform a study on improving the port's morphological characteristics and facilities, to accommodate anchoring and mooring ships under bad weather conditions, taking into consideration views of the Masters of regularly visiting types of ships.
