SAFETY RECOMMENDATION No: 12/2014

No of Safety Investigation Report:	02/2014: Grounding of B/C "INCE INEBOLU" (See the full Report here.)
Safety Recommendation addressed to:	Managers/Owners
Date of publication:	31/12/2015

Grounding of B/C "INCE INEBOLU"

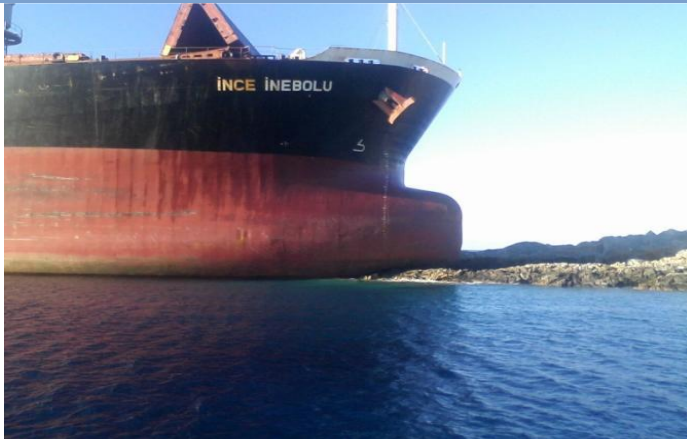
Grounding point of Ince Inebolu at Astypalaia Island.

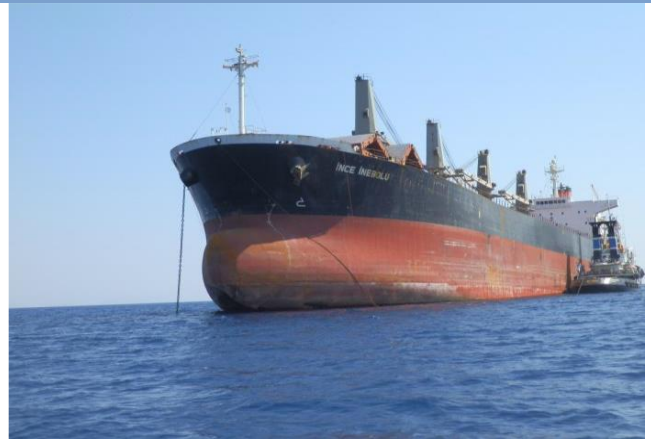
Ince Inebolu anchored at Astypalaia.

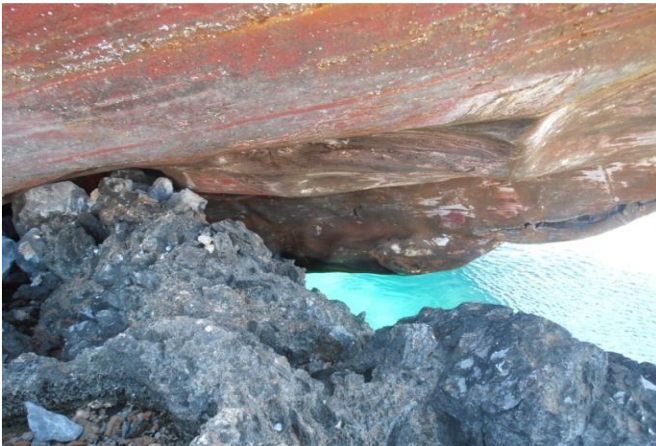
Due to the heavy impact on the rocky coastline, several compartments of her bow section were damaged to an extent of about 21 m of length longitudinally. More specific the damages reported to be cracks and hull plating deformation at forepeak tank, collision bulkhead, No. 1 cargo Hold, No 1 port and starboard ballast tanks. No injuries and no pollution was reported.

Deformed starboard bottom fore section.

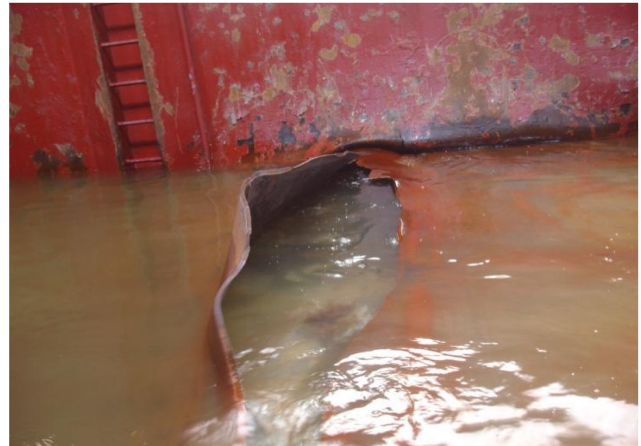
The crack at inner bottom plate of No 1 cargo hold.
