## SAFETY RECOMMENDATION No: 13/2012

<b>No of Safety Investigation Report:</b>	01/2012: Fire on board Ro-Pax “KRITI II” (See the full Report <a href="#">here.</a> )
---	--

#### **Fire inside the garage space of Ro-Pax**

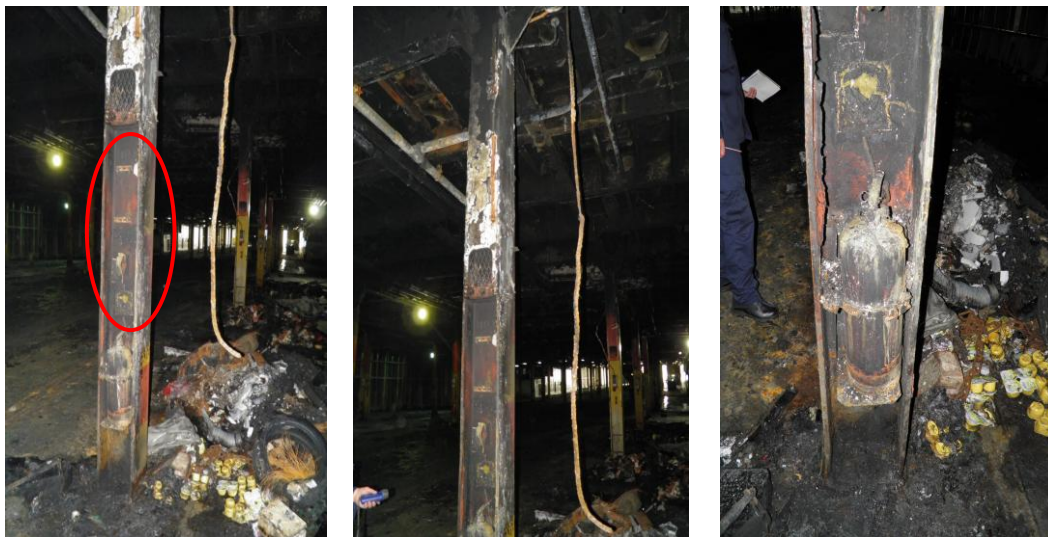
According to the collected data during the technical investigation, although documented monthly reports of the resistances of the electrical installation's equipment by performing tests with the Megger device (Megger Test) by the Chief Electrician and the ship's Electrical Sector's personnel were satisfactory, however, a number of sockets were found with residues of sockets' terminals at the connection points, which were the result of the development of an electric arc due to their bad connection.

The pillar between frames 219-221, which was found with increased fire indicators in its fore side, the base of the socket and the cut cable. Also fusion signs of the socket material are evident on the fire extinguisher and the deck.
