SAFETY RECOMMENDATION No: 13/2013

No of Safety Investigation Report:	03/2013: Foundering of barge "AGIOS DIONYSIOS" (See the full Report here.)
---	--

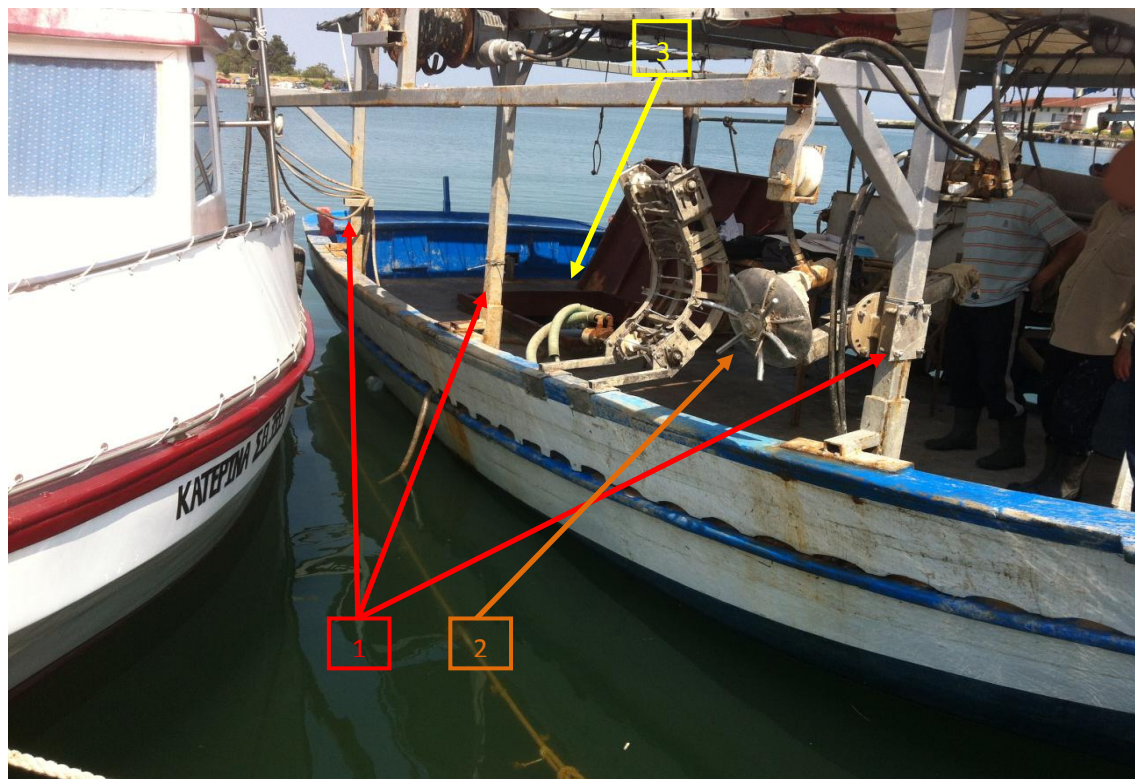
Picture 1: Photo of the vessel where appears the unit for the suspension of mussels (1), the hydraulic mechanism to remove the mussels from the sea (2) and the engine cover (3).

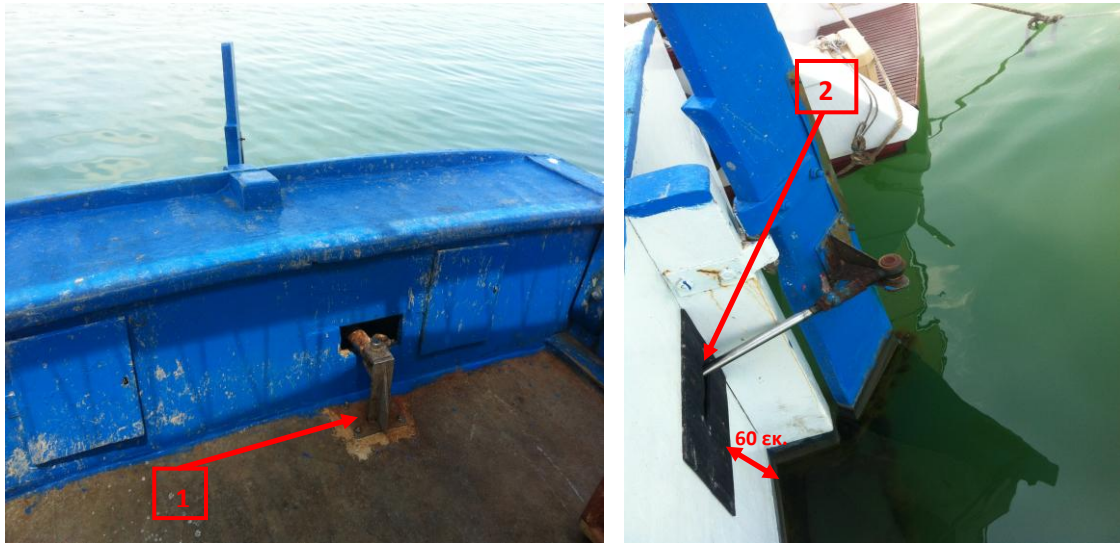
According to the collected data of the conducted investigation, it is presumed that the vessel's sinking was due to water ingress in the engine area, which should be watertight. This ingress derived from holes in the aft deck and stern transom, from which the steering mechanism passed. The area of openings was covered by a wooden structure, which did not allow the detection of water ingress by the Skipper or the other persons on board.

Picture 2: The bearing point of steering gear (1) and the point from which the rudder mechanism penetrated the hull of the ship (2).

Issuing a new License for Performance of Voyages, after retrofitting and defining the maximum allowed load and passengers, as well as freeboard height, according to the provisions of General Port Regulation 23.
