SAFETY RECOMMENDATION No: 13/2014

02/2014: Grounding of B/C "INCE INEBOLU" (See the full Report [here.](#))

Grounding of B/C "INCE INEBOLU"

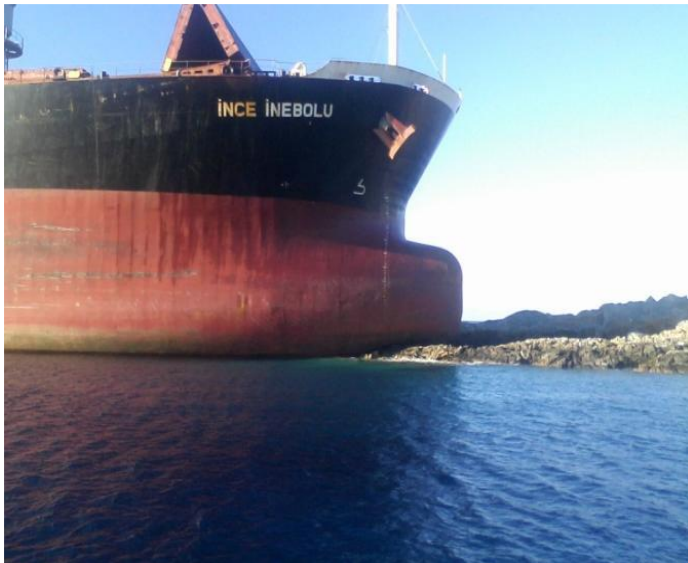
Grounding point of Ince Inebolu at Astypalaia Island

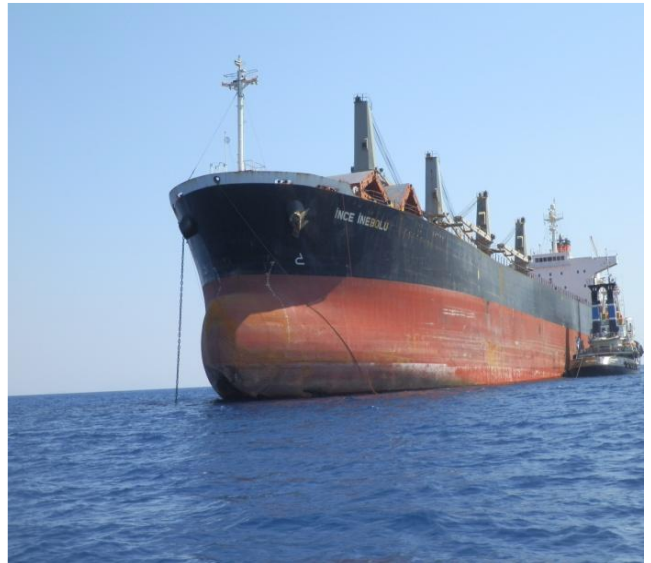
Ince Inebolu anchored at Astypalaia

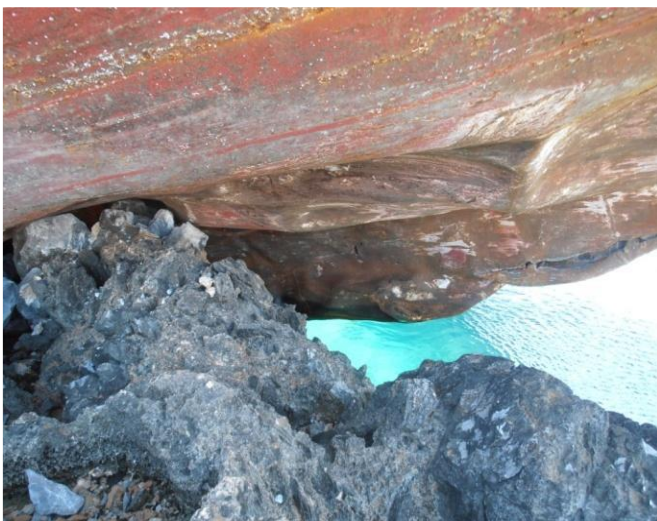
Due to the heavy impact on the rocky coastline, several compartments of her bow section were damaged to an extent of about 21 m of length longitudinally. More specific the damages reported to be cracks and hull plating deformation at forepeak tank, collision bulkhead, No. 1 cargo Hold, No 1 port and starboard ballast tanks. No injuries and no pollution was reported.

Deformed starboard bottom fore section.

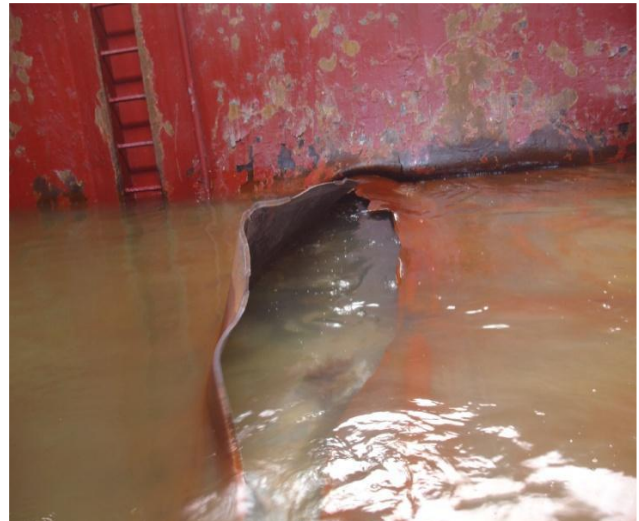
The crack at inner bottom plate of No 1 cargo hold.
