SAFETY RECOMMENDATION No: 13/2014

02/2014: Grounding of B/C "INCE INEBOLU" (*See the full Report [here.](#)*)

Grounding of B/C "INCE INEBOLU"

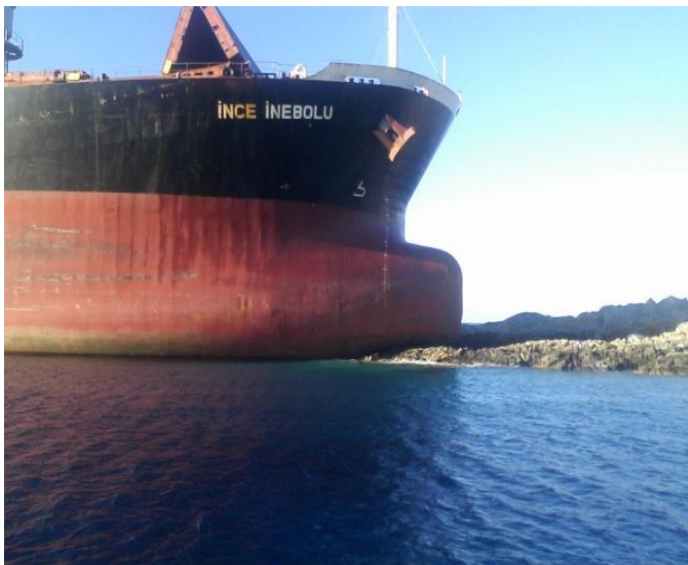
Grounding point of Ince Inebolu at Astypalaia Island

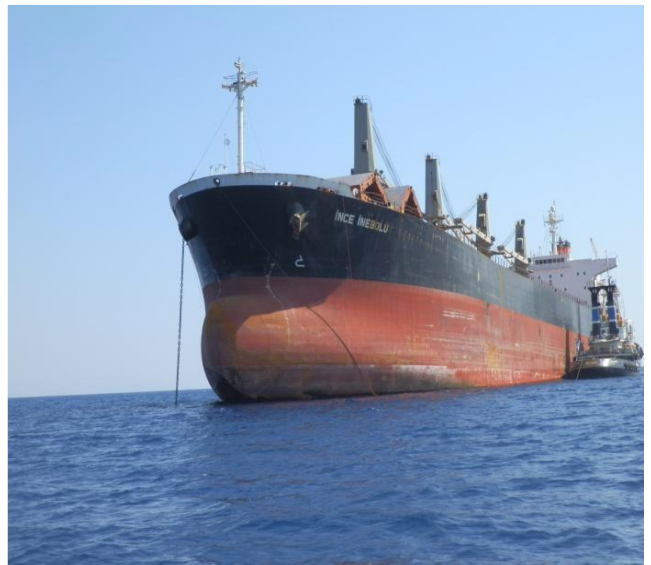
Ince Inebolu anchored at Astypalaia
