## SAFETY RECOMMENDATION No: 14/2012

01/2012: Fire on board Ro-Pax "KRITI II"  
(See the full Report [here.](#))

### **Fire inside the garage space of Ro-Pax**

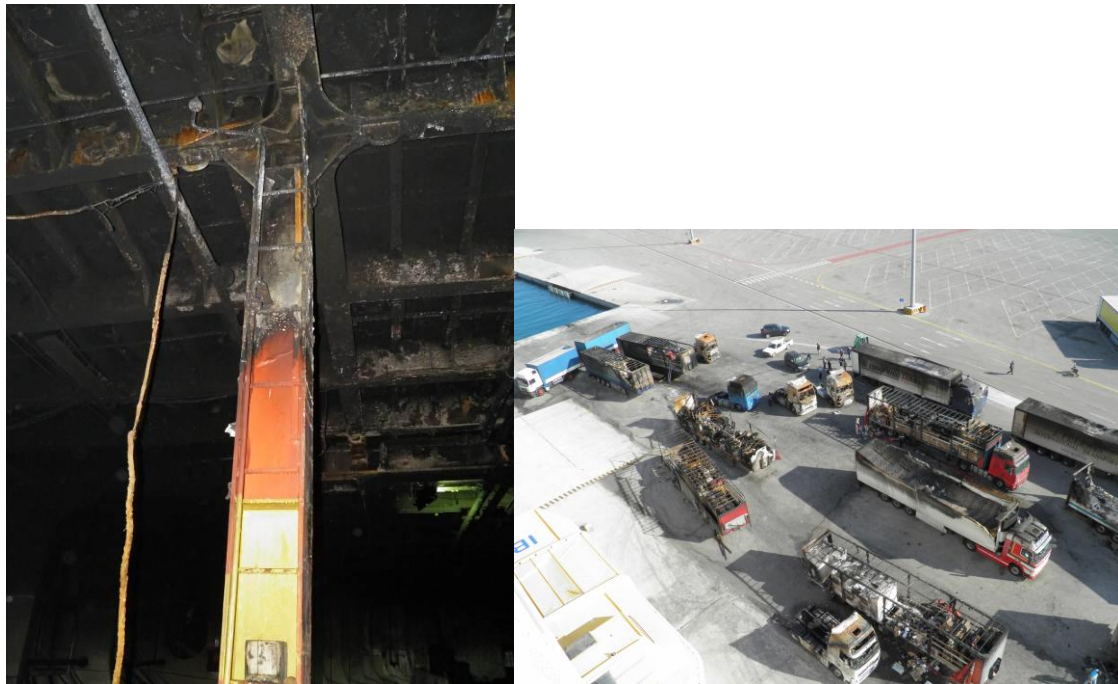
Photos of the damages on the top of the garage and trucks

The consequences of the examined accident were confined to a limited damage to the ship and extensive damage to trucks which were in the vicinity of the seat of the fire in the main garage.

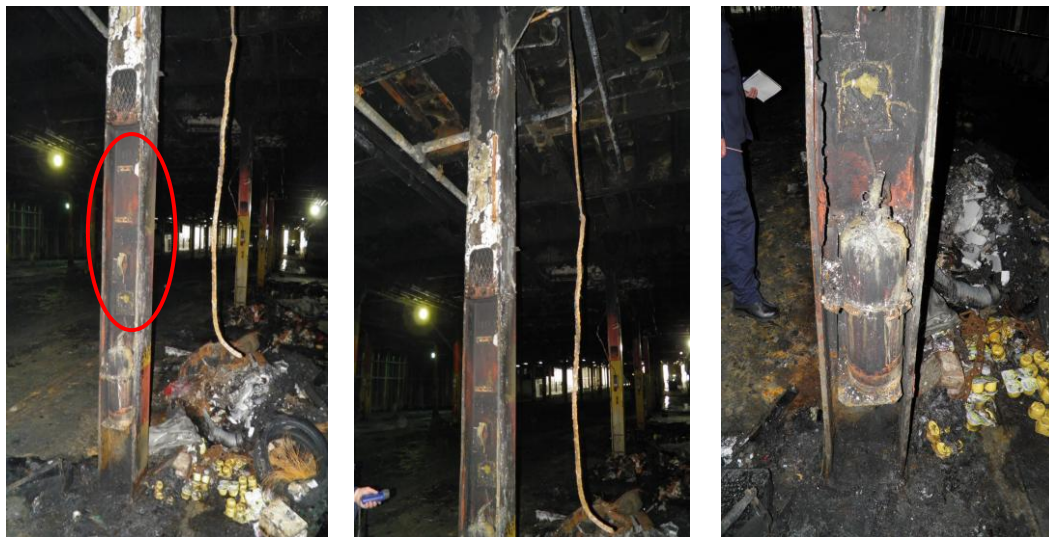
According to the collected data during the technical investigation, although documented monthly reports of the resistances of the electrical installation's equipment by performing tests with the Megger device (Megger Test) by the Chief Electrician and the ship's Electrical Sector's personnel were satisfactory, however, a number of sockets were found with residues of sockets' terminals at the connection points, which were the result of the development of an electric arc due to their bad connection.

The pillar between frames 219-221, which was found with increased fire indicators in its fore side, the base of the socket and the cut cable. Also fusion signs of the socket material are evident on the fire extinguisher and the deck.
