SAFETY RECOMMENDATION No: 14/2013

No of Safety Investigation Report:	03/2013: Foundering of barge "AGIOS DIONYSIOS" <i>(See the full Report here.)</i>
---	--

Foundering of barge

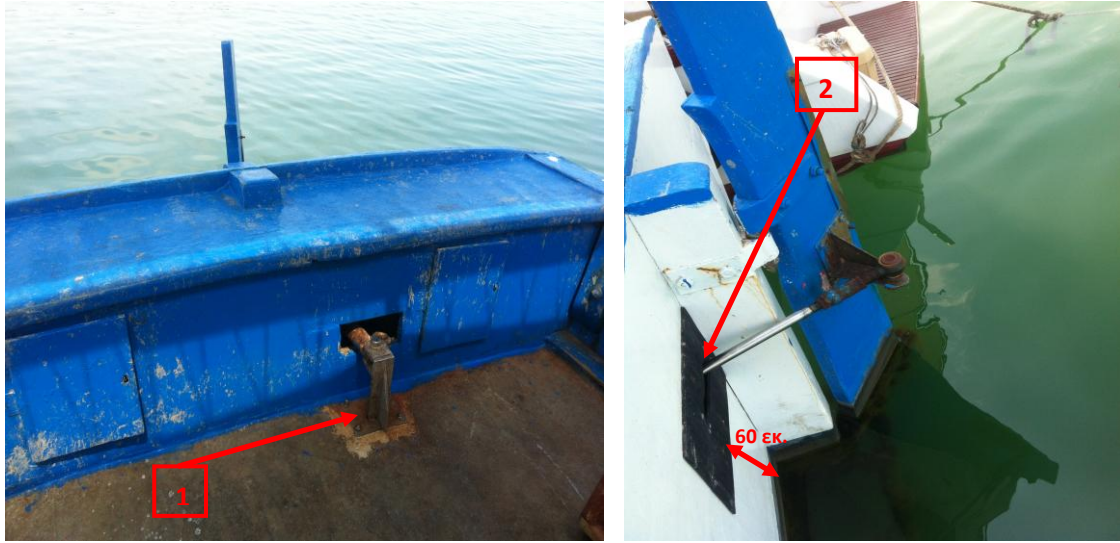
According to the collected data of the conducted investigation, it is presumed that the vessel's sinking was due to water ingress in the engine area, which should be watertight. This ingress derived from holes in the aft deck and stern transom, from which the steering mechanism passed. The area of openings was covered by a wooden structure, which did not allow the detection of water ingress by the Skipper or the other persons on board.

Picture 2: The bearing point of steering gear (1) and the point from which the rudder mechanism penetrated the hull of the ship (2).

Considering the installation of an audio visual alarm system for the increase of engine space bilge water level.
