SAFETY RECOMMENDATION No: 14/2014

02/2014: Grounding of B/C "INCE INEBOLU"
(See the full Report [here.](#))

Grounding of B/C "INCE INEBOLU"

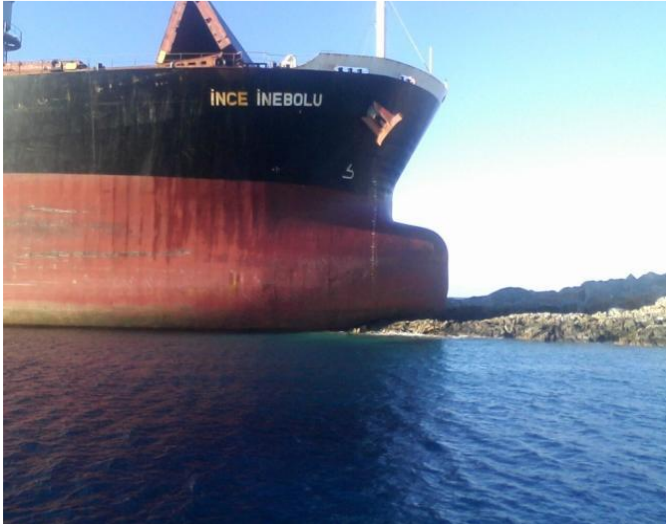
At approximately 0405 Ince Inebolu while running at approximately 13 knots, grounded on the south east rocky coastline of Astypalaia Island-Greece. At the time of the marine casualty the relieving Navigational Officer had not been called for duty. Weather conditions were reported to be very good (wind force 2-3 bfrs, sea state calm with very good visibility) and it was still dark.

Grounding point of Ince Inebolu at Astypalaia Island.

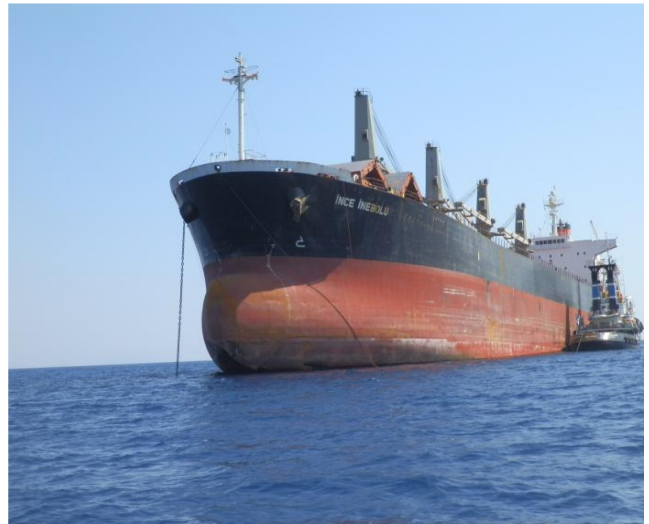
Ince Inebolu anchored at Astypalaia.

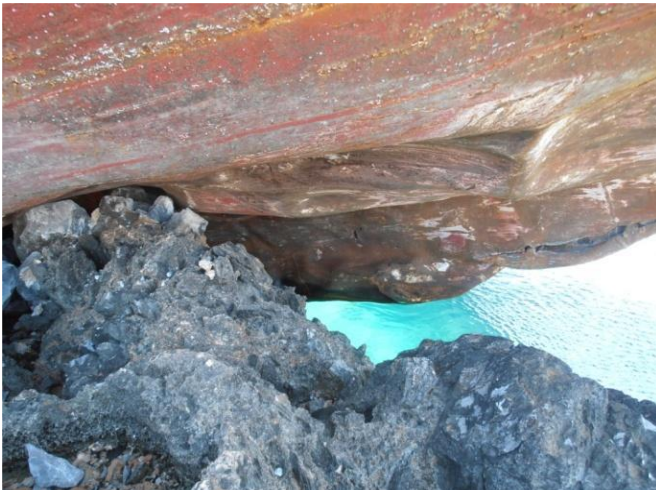
Due to the heavy impact on the rocky coastline, several compartments of her bow section were damaged to an extent of about 21 m of length longitudinally. More specific the damages reported to be cracks and hull plating deformation at forepeak tank, collision bulkhead, No. 1 cargo Hold, No 1 port and starboard ballast tanks. No injuries and no pollution was reported.

Deformed starboard fore bottom section.

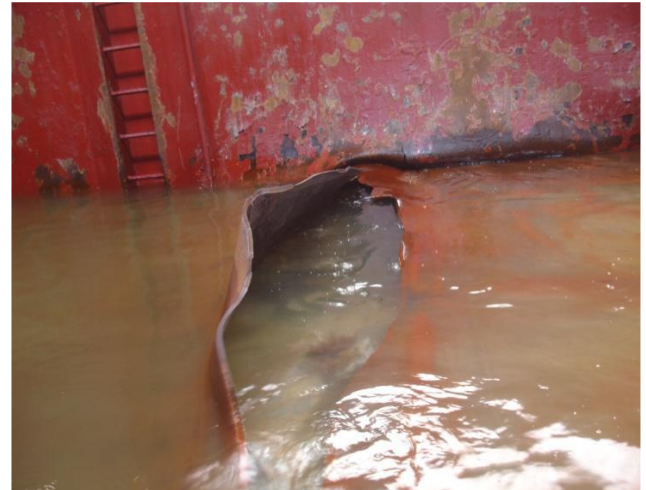
The crack at inner bottom plate of No 1 cargo hold.
