SAFETY RECOMMENDATION No: 15/2014

No of Safety Investigation Report: 02/2014: Grounding of B/C "INCE INEBOLU"
(See the full Report [here.](#))

Grounding of B/C "INCE INEBOLU"

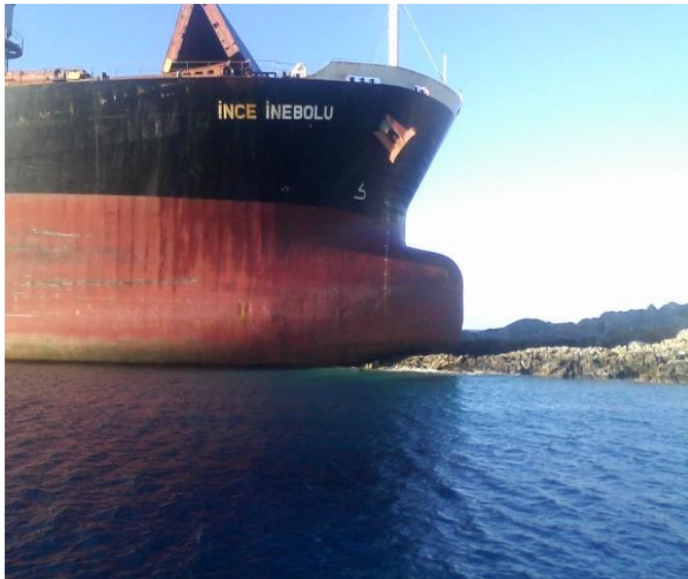
Grounding point of Ince Inebolu at Astypalaia Island.

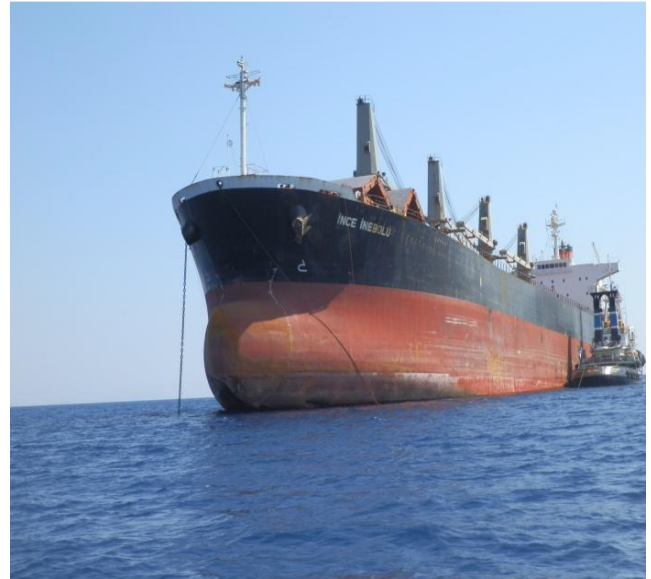
Ince Inebolu anchored at Astypalaia

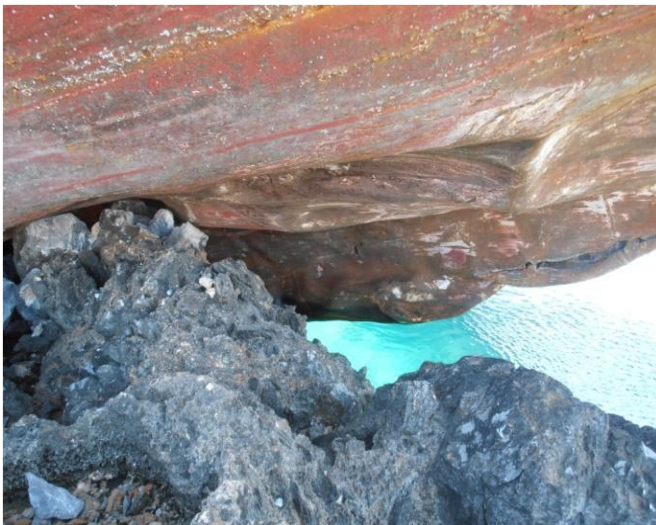
Due to the heavy impact on the rocky coastline, several compartments of her bow section were damaged to an extent of about 21 m of length longitudinally. More specific the damages reported to be cracks and hull plating deformation at forepeak tank, collision bulkhead, No. 1 cargo Hold, No 1 port and starboard ballast tanks. No injuries and no pollution was reported.

Deformed starboard fore bottom section.

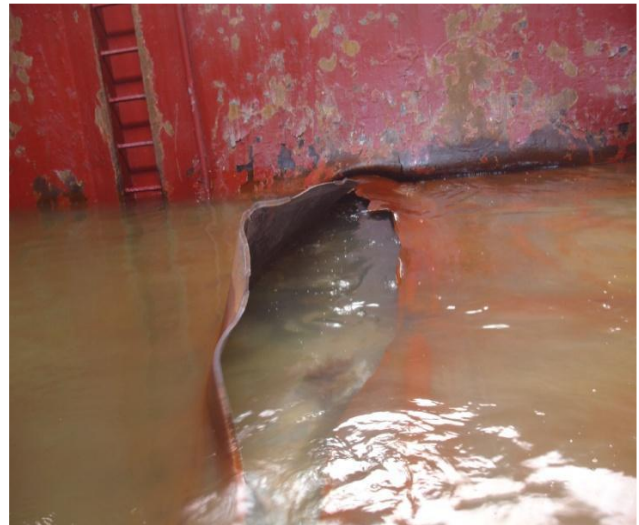
The crack at inner bottom plate of No 1 cargo hold.
