SAFETY RECOMMENDATION No: 15/2015

03/2015: Death by asphyxiation of the Bosun of Bulk Carrier KOSMAS V, Panama Flag, IMO 9445681, after entering a cargo hold

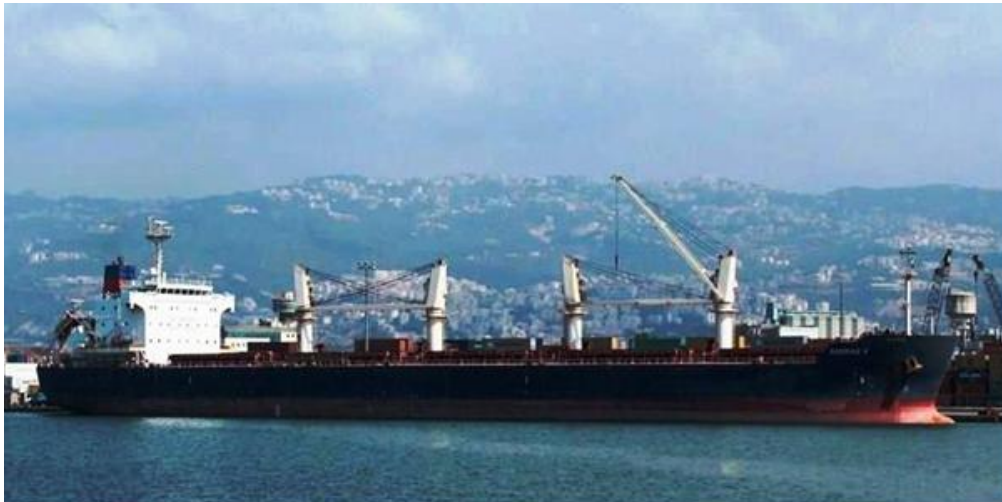
Bulk carrier KOSMAS V.
