## SAFETY RECOMMENDATION No: 16/2014

**No of Safety Investigation Report:** 02/2014: Grounding of B/C “INCE INEBOLU”  
(See the full Report [here.](#))

### Grounding of B/C “INCE INEBOLU”

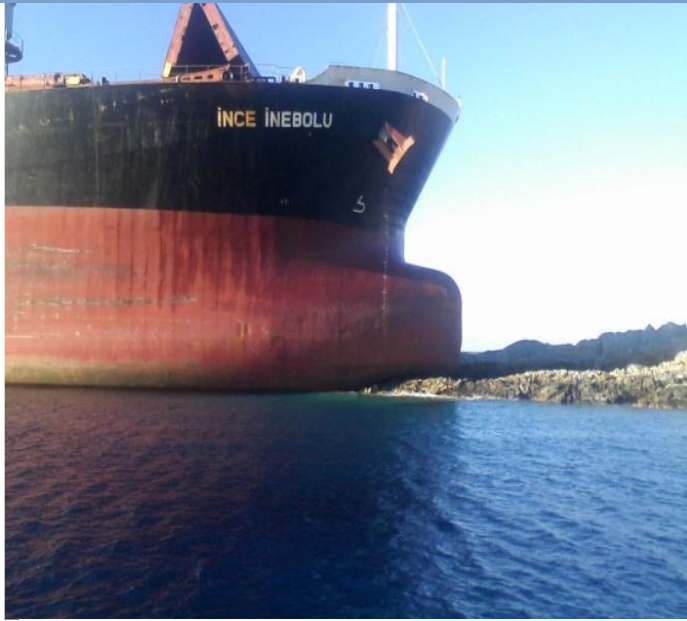
Grounding point of Ince Inebolu at Astypalaia Island

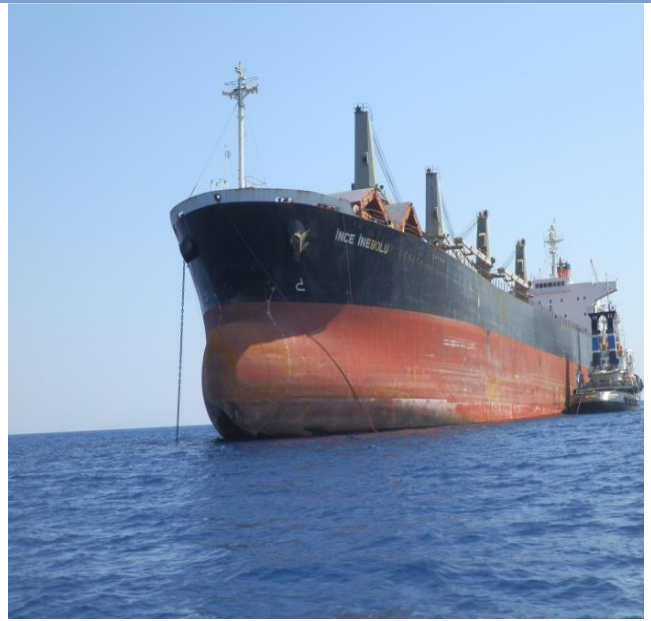
Ince Inebolu anchored at Astypalaia

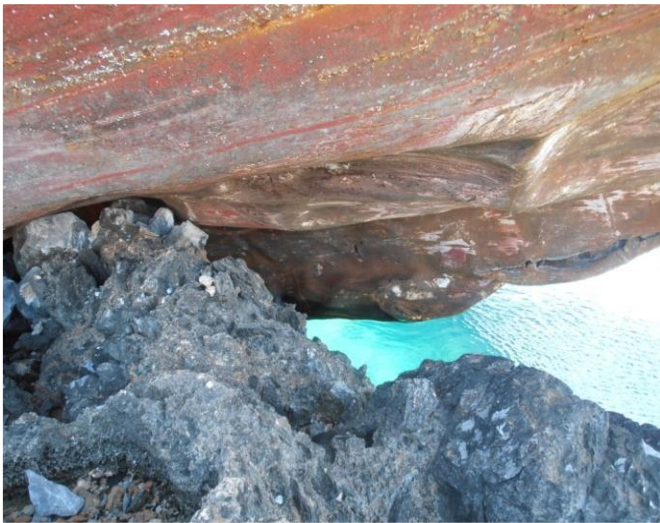
Due to the heavy impact on the rocky coastline, several compartments of her bow section were damaged to an extent of about 21 m of length longitudinally. More specific the damages reported to be cracks and hull plating deformation at forepeak tank, collision bulkhead, No. 1 cargo Hold, No 1 port and starboard ballast tanks. No injuries and no pollution was reported.

Deformed starboard fore bottom section.

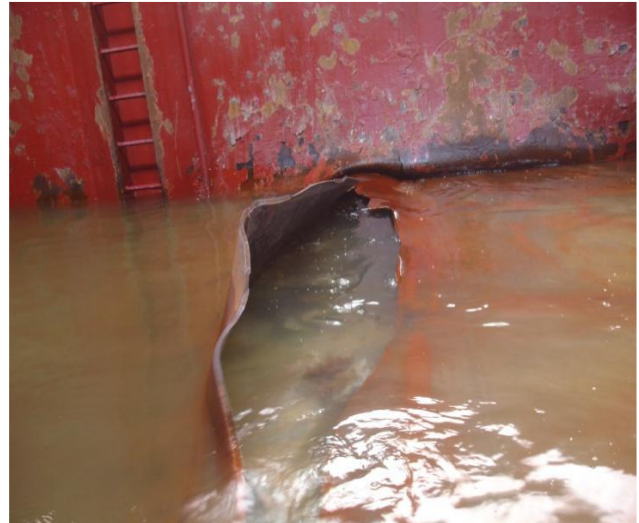
The crack at inner bottom plate of No 1 cargo hold.
