SAFETY RECOMMENDATION No: 17/2014

No of Safety Investigation Report: 02/2014: Grounding of B/C "INCE INEBOLU"
(See the full Report [here.](#))

Grounding of B/C "INCE INEBOLU"

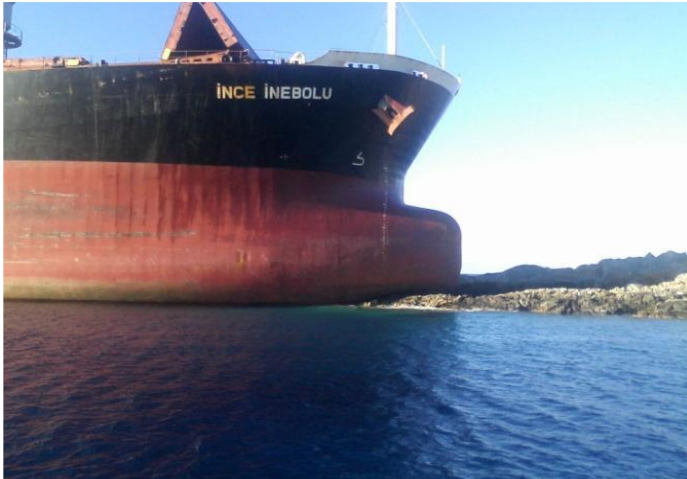
Grounding point of Ince Inebolu at Astypalaia Island.

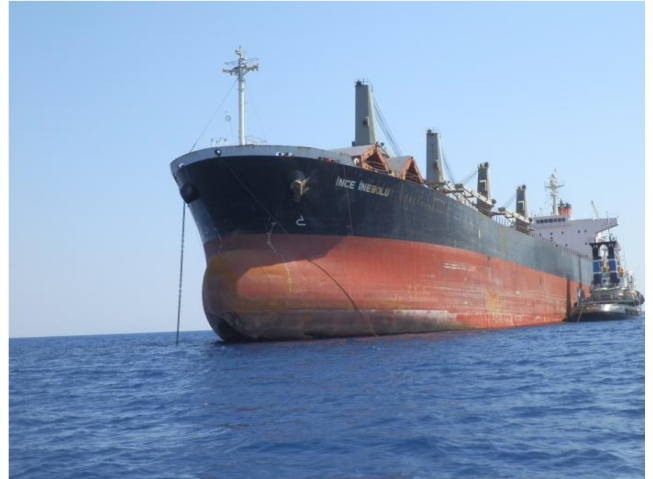
Ince Inebolu anchored at Astypalaia.

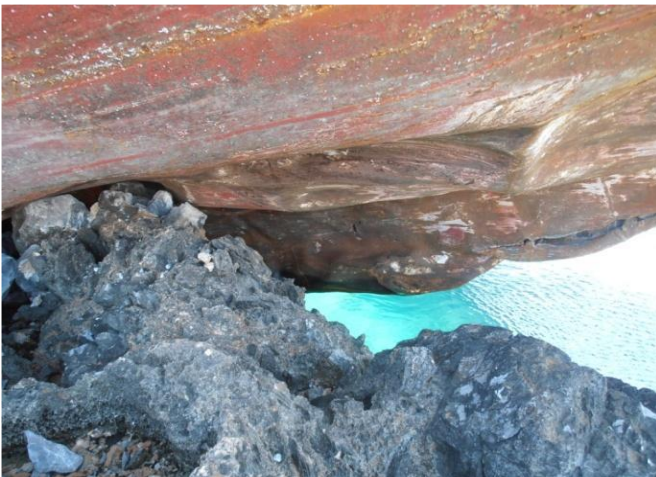
Due to the heavy impact on the rocky coastline, several compartments of her bow section were damaged to an extent of about 21 m of length longitudinally. More specific the damages reported to be cracks and hull plating deformation at forepeak tank, collision bulkhead, No. 1 cargo Hold, No 1 port and starboard ballast tanks. No injuries and no pollution was reported.

Deformed starboard bottom fore section.

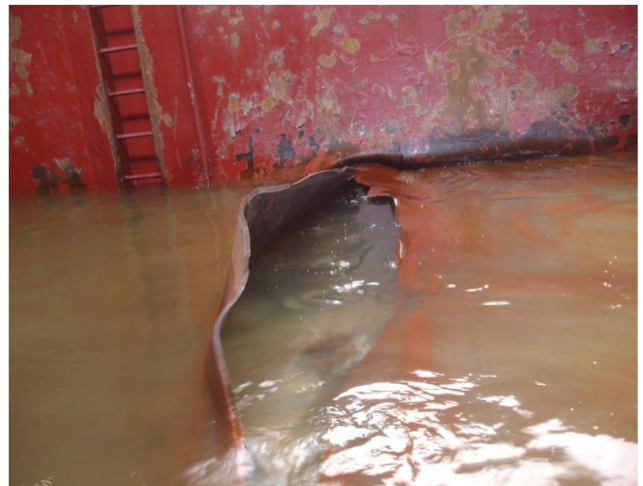
The crack at inner bottom plate of No 1 cargo hold.
