## SAFETY RECOMMENDATION No: 18/2013

04/2013: Foundering of tug boat "ARTEMIS V" by M/V "JSM"  
(See the full Report [here.](#))

### Foundering of tug boat and death of a seaman

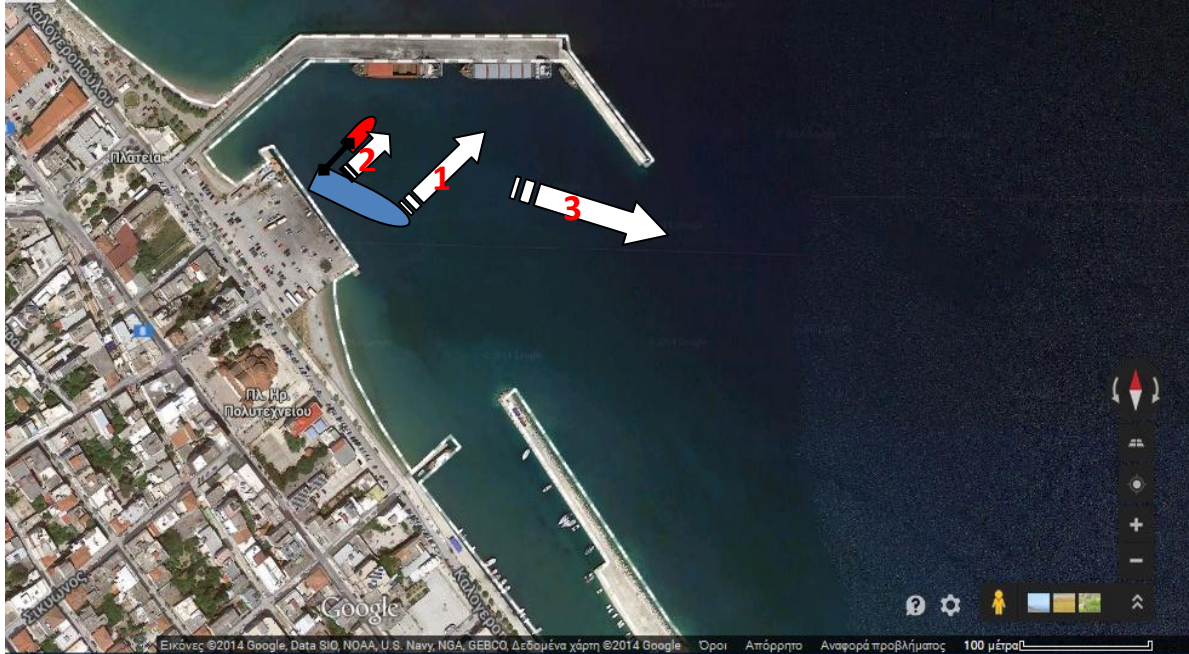
**Picture 1:** Schematic illustration of the maneuvering as planned by the Master of JSM (blue vessel):

- (1) casting the bow off the dock by vessel's lines,
- (2) sheering vessel's stern off the dock by ARTEMIS (red boat), so that JSM was able to head to port exit,
- (3) JSM exits from the port with her means.

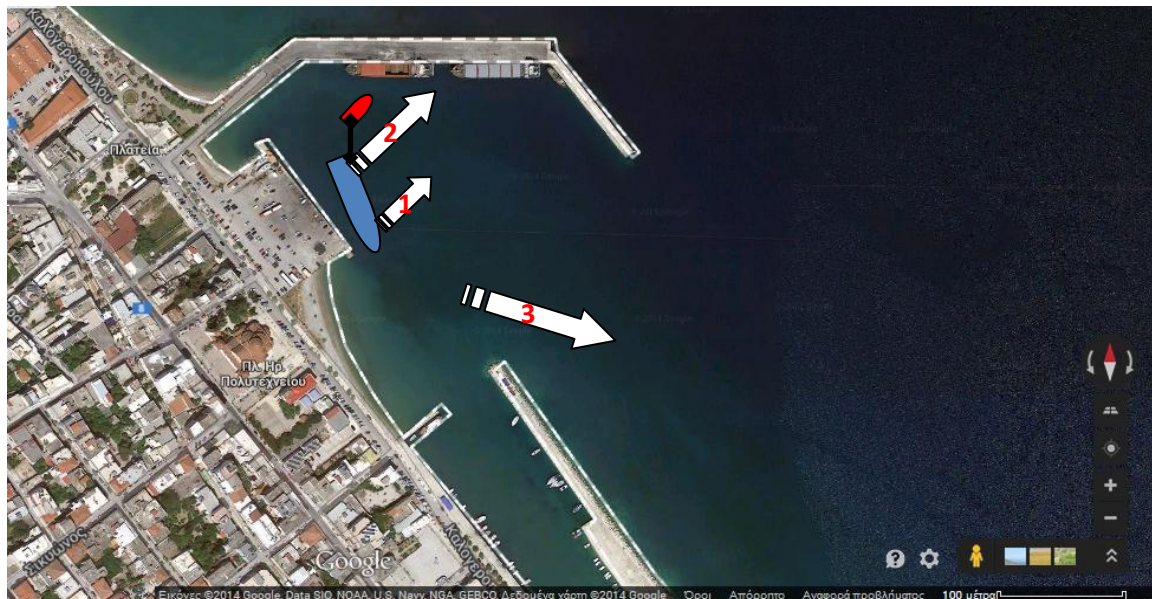
The increase of speed by the M/V, with heading hard to port in order to prevent the hazardous situation, as the tug boat did not release the towline, created increasing list to the starboard of the tug boat (athwartships forces on the tugboat – high risk situation "T"), so that the tug boat suffered water ingress and consequent sank. The M/V continued her movement and left the port after collecting the towline, which was self-released by the hook of tug boat due to buoyancy.

**Picture 2:** Schematic illustration of the maneuvering of JSM (blue vessel):

- (1) casting JSM bow off the dock by vessel aft spring line,
  - (2) sheering JSM stern off the dock by ARTEMIS V (red boat), causing a rapid turn of JSM bow to starboard and towards the dock, rendering ship's position in a hazardous situation in relation to her safe exit from the port.
  - (3) JSM exit from the port with her own means while pulling ARTEMIS V as she was being dragged on sea bed.
- (The dimensions of vessels and towline are not scaled. Map Source: Google Maps, <http://maps.google.com/>)

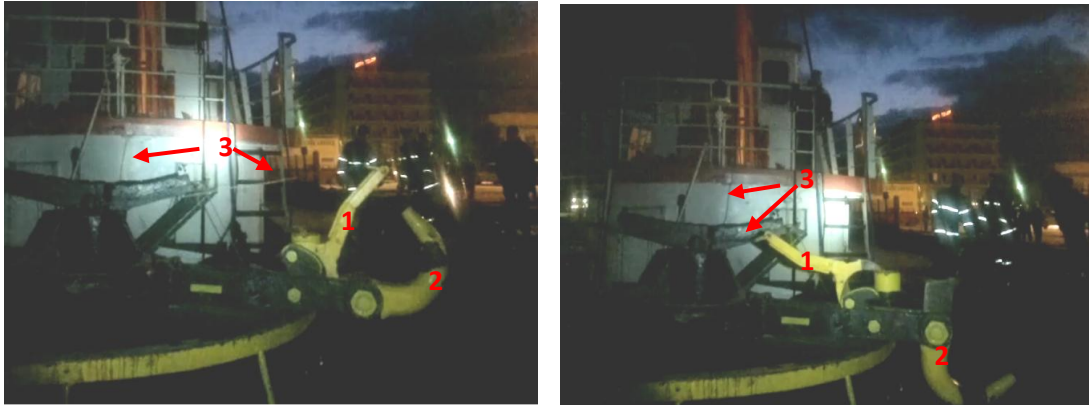
Additionally the weathertight - watertight openings of tug boat were left open during the towage, while the arrangement for releasing the tug's tow line was only operated from inside the wheelhouse and was not ergonomic and especially for use in hazardous or emergency situations precarious list of the boat. Thus the release of the tow line was not performed when the tug boat suddenly developed increasing list.

**Picture 3:** Arrangement of the quick release mechanism of ARTEMIS V. The releasing phases prior to activation (on the left) and past activation (on the right). 1: Hook fastening arm, 2: Towing hook, 3: Release wire from the coupled jointed arm to the bridge.

- Regulating issues relating to the operation of the towline release mechanism on Tugs used in Ports, its testing methods and frequency.
- Compulsory provision of an alternative arrangement and location for the handling of the towline release mechanism.

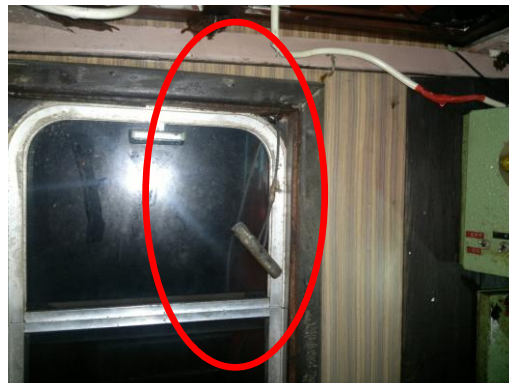
**Picture 4:** The lever release of the immediate release system of the tugs to the steering space of tug boat.
