SAFETY RECOMMENDATION No: 19/2013

04/2013: Foundering of tug boat "ARTEMIS V"
by M/V "JSM"
(See the full Report [here.](#))

Foundering of tug boat and death of a seaman

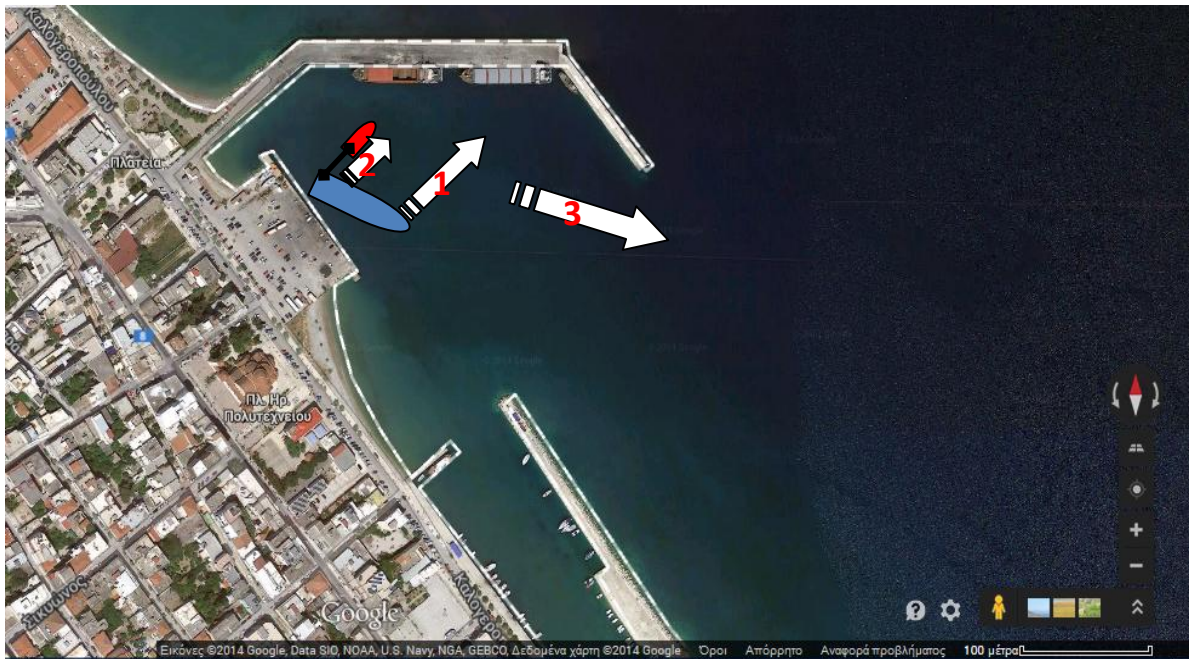
Picture 1: Schematic illustration of the maneuvering as planned by the Master of JSM (blue vessel):

- (1) casting the bow off the dock by vessel's lines,
- (2) sheering vessel's stern off the dock by ARTEMIS (red boat), so that JSM was able to head to port exit,
- (3) JSM exits from the port with her means.

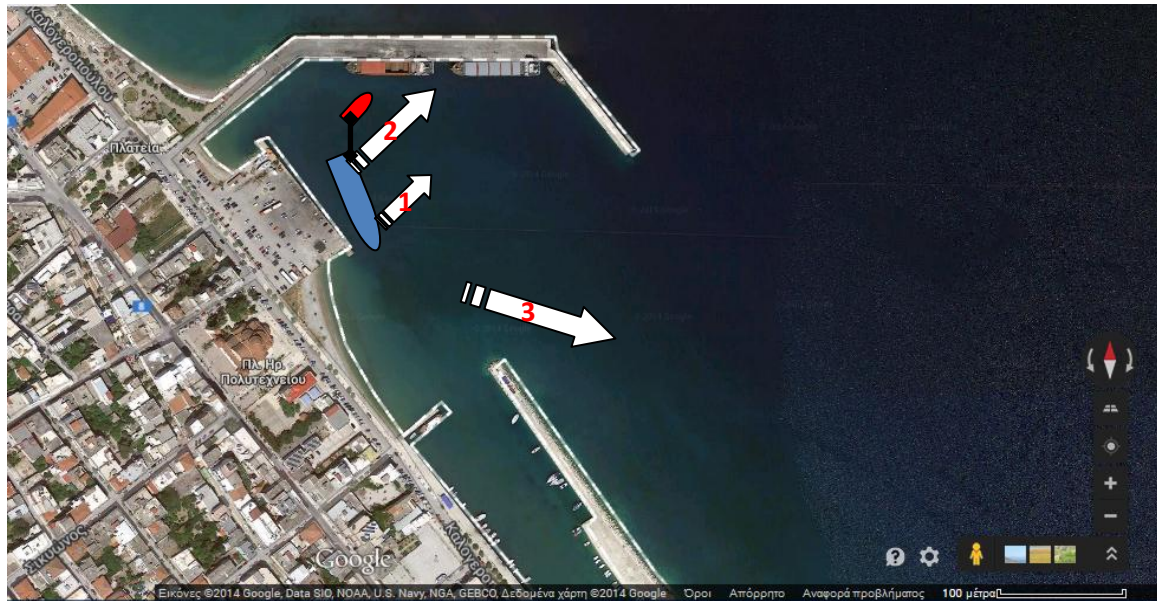
The M/V cast off her bow from the pier by using the stern spring (aft spring line) and according to the plan the stern would be drawn away by the tug boat. However, according to the master of the M/V the tug boat pulled more power than expected the stern of the M/V resulting in giving her a heading which posed a risk of grounding or crashing on the jetty of the fishing shelter of the port.

The increase of speed by the M/V, with heading hard to port in order to prevent the hazardous situation, as the tug boat did not release the towline, created increasing list to the starboard of the tug boat (athwartships forces on the tugboat – high risk situation "T"), so that the tug boat suffered water ingress and consequent sank. The M/V continued her movement and left the port

Picture 2: Schematic illustration of the maneuvering of JSM (blue vessel):

- (1) casting JSM bow off the dock by vessel aft spring line,
 - (2) sheering JSM stern off the dock by ARTEMIS V (red boat), causing a rapid turn of JSM bow to starboard and towards the dock, rendering ship's position in a hazardous situation in relation to her safe exit from the port.
 - (3) JSM exit from the port with her own means while pulling ARTEMIS V as she was being dragged on sea bed.
- (The dimensions of vessels and towline are not scaled. Map Source: Google Maps, <http://maps.google.com/>)

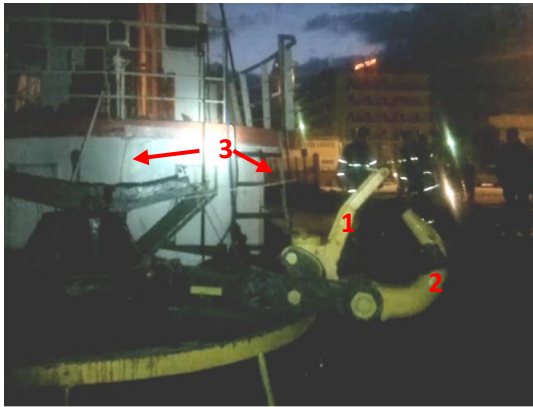
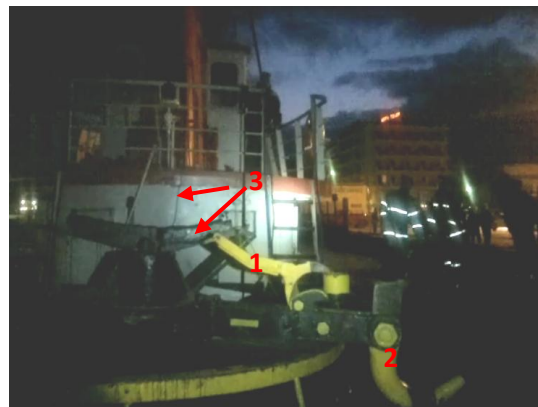
Additionally the weathertight - watertight openings of tug boat were left open during the towage, while the arrangement for releasing the tug's tow line was only operated from inside the wheelhouse and was not ergonomic and especially for use in hazardous or emergency situations precarious list of the boat. Thus the release of the tow line was not performed when the tug boat suddenly developed increasing list.

Picture 3: Arrangement of the quick release mechanism of ARTEMIS V. The releasing phases prior to activation (on the left) and past activation (on the right). 1: Hook fastening arm, 2: Towing hook, 3: Release wire from the coupled jointed arm to the bridge.

- The ergonomic arrangement for the activation of the towline release mechanism of Tugs used in Ports.
- Regulating the operational capabilities Tugs used in Ports in relation to their required technical characteristics (engine power, towing force, etc.) and measures concerning the maintaining of watertight and weathertight openings in a closed position during towing operations as well as relevant marking.

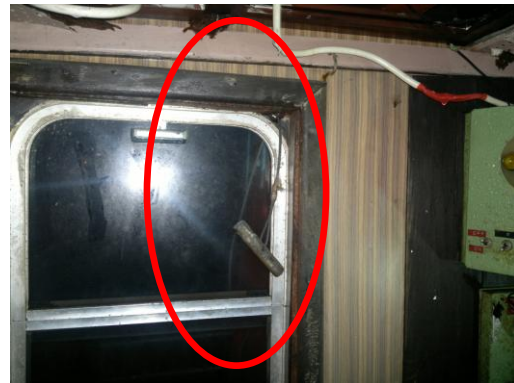
Picture 4: The lever release of the immediate release system of the tugs to the steering space of tug boat.
