## SAFETY RECOMMENDATION No: 19/2014

02/2014: Grounding of B/C "INCE INEBOLU"  
(See the full Report [here.](#))

## Grounding of B/C "INCE INEBOLU"

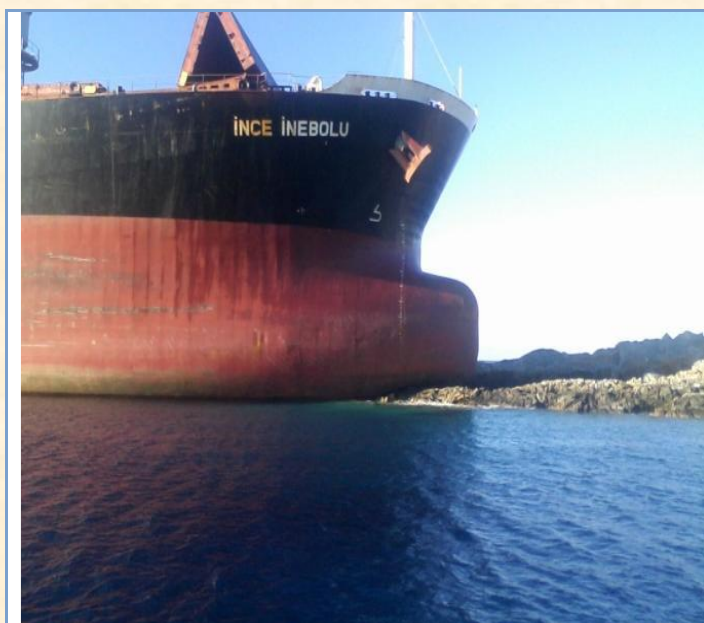
According to crew reports, on 03 September during the Suez Canal crossing, the Bridge Navigational Watch Alarm System (BNWAS) had been deactivated, and since then it had not been reactivated. At approximately 0405 Ince Inebolu while running at approximately 13 knots, grounded on the south east rocky coastline of Astypalaia Island-Greece. At the time of the marine casualty the relieving Navigational Officer had not been called for duty. Weather conditions were reported to be very good (wind force 2-3 bfrs, sea state calm with very good visibility) and it was still dark.

Grounding point of Ince Inebolu at Astypalaia Island.

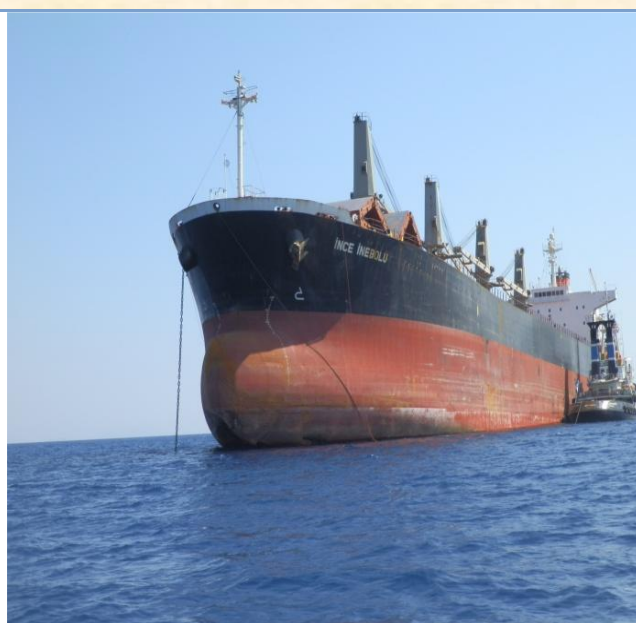
Ince Inebolu anchored at Astypalaia.

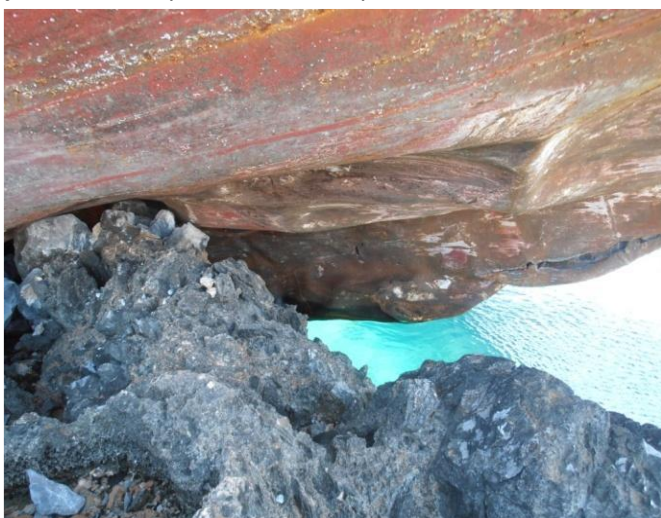
Due to the heavy impact on the rocky coastline, several compartments of her bow section were damaged to an extent of about 21 m of length longitudinally. More specific the damages reported to be cracks and hull plating deformation at forepeak tank, collision bulkhead, No. 1 cargo Hold, No 1 port and starboard ballast tanks. No injuries and no pollution was reported.

Deformed starboard fore bottom section.

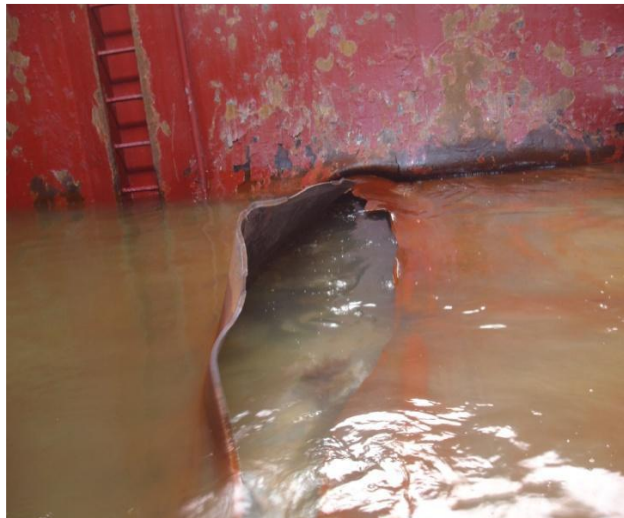
The crack at inner bottom plate of No 1 cargo hold.
