SAFETY RECOMMENDATION No: 20/2014

No of Safety Investigation Report:	02/2014: Grounding of B/C "INCE INEBOLU" (See the full Report here.)
Safety Recommendation addressed to:	The Competent Authority of the Shipping Administration for issuing Minimum Safe Manning Document
Date of publication:	31/12/2015

Grounding of B/C "INCE INEBOLU"

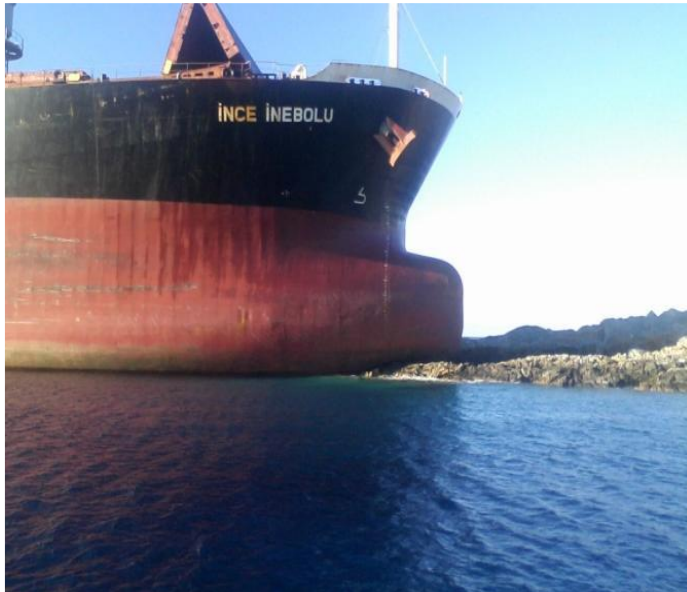
According to crew reports, on 03 September, during the Suez Canal crossing, the Bridge Navigational Watch Alarm System (BNWAS) had been deactivated and it had not been reactivated since then. At approximately 0405 Ince Inebolu while running at approximately 13 knots, grounded on the south east rocky coastline of Astypalaia Island-Greece. At the time of the marine casualty the relieving Navigational Officer had not been called for duty. Weather conditions were reported to be very good (wind force 2-3 bfrs, sea state calm with very good visibility) and it was still dark.

Grounding point of Ince Inebolu at Astypalaia Island.

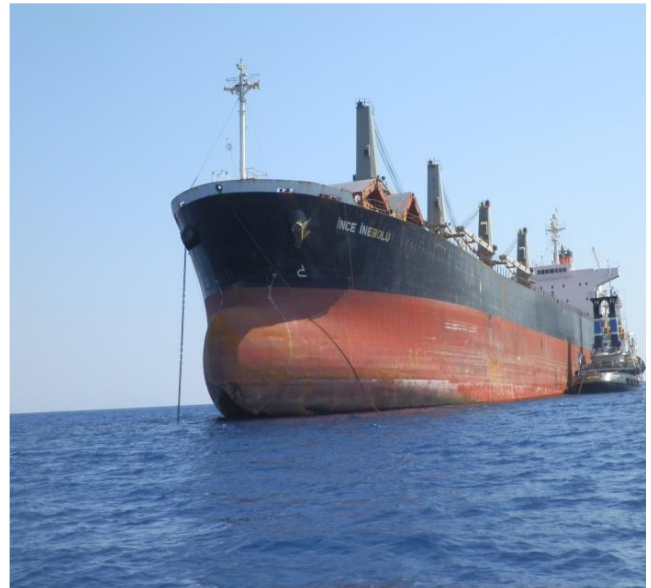
Ince Inebolu anchored at Astypalaia.

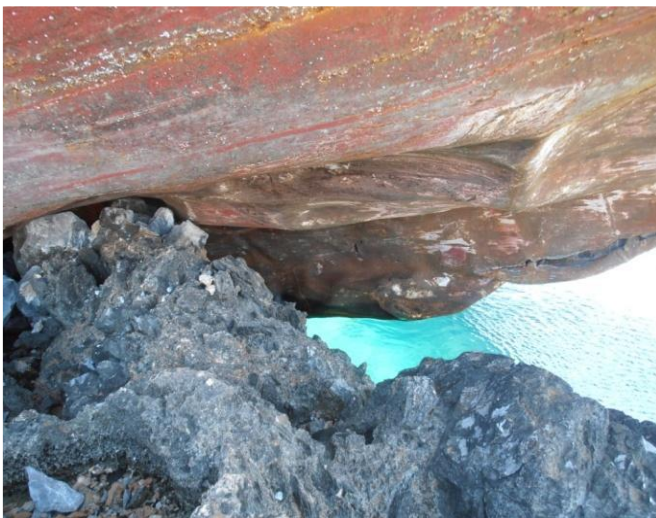
Due to the heavy impact on the rocky coastline, several compartments of her bow section were damaged to an extent of about 21 m of length longitudinally. More specific the damages reported to be cracks and hull plating deformation at forepeak tank, collision bulkhead, No. 1 cargo Hold, No 1 port and starboard ballast tanks. No injuries and no pollution was reported.

Deformed starboard fore bottom section.

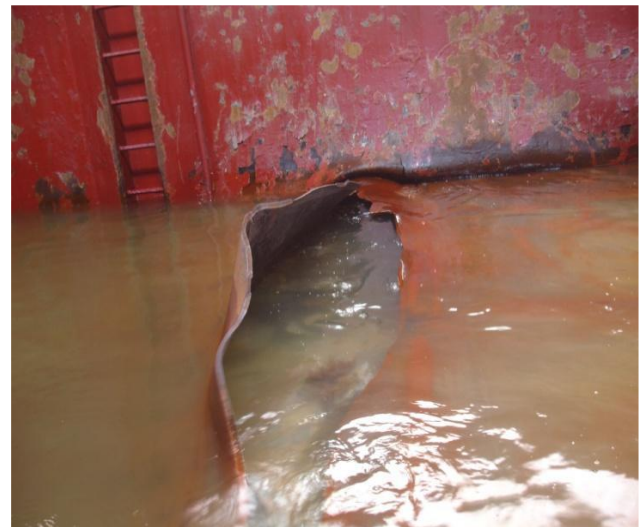
The crack at inner bottom plate of No 1 cargo hold.
