SAFETY RECOMMENDATION No: 22/2013

No of Safety Investigation Report:	04/2013: Foundering of tug boat "ARTEMIS V" by M/V "JSM" (See the full Report here.)
---	---

Foundering of tug boat and death of a seaman

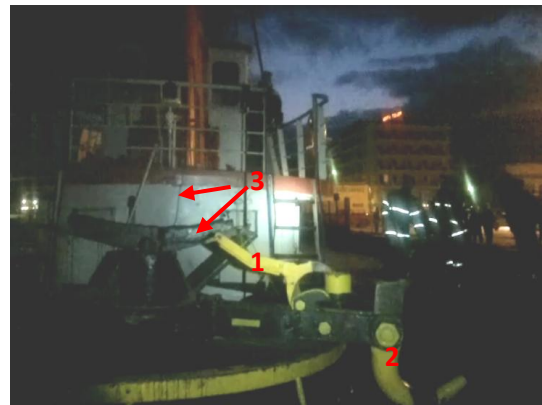
Additionally the weathertight - watertight openings of tug boat were left open during the towage, while the arrangement for releasing the tug's tow line was only operated from inside the wheelhouse and was not ergonomic and especially for use in hazardous or emergency situations precarious list of the boat. Thus the release of the tow line was not performed when the tug boat suddenly developed increasing list.

Picture 3: Arrangement of the quick release mechanism of ARTEMIS V. The releasing phases prior to activation (on the left) and past activation (on the right). 1: Hook fastening arm, 2: Towing hook, 3: Release wire from the coupled jointed arm to the bridge.

The Tug boat and Salvage Associations should inform their members regarding the importance of keeping watertight and weathertight openings of Tugboats in the closed position when engaged in towing operations and advise the conduct of tests of towline release mechanism by the tug's crew prior to towing operations.

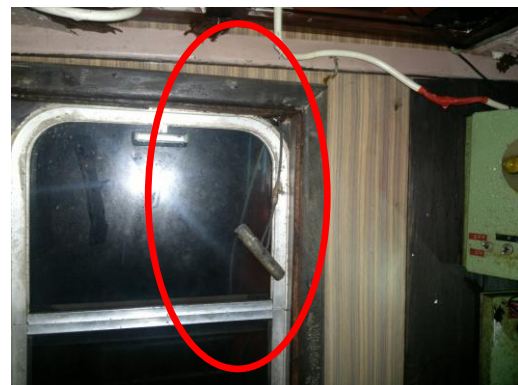
Picture 4: The lever release of the immediate release system of the tugs to the steering space of tug boat.
