## SAFETY RECOMMENDATION No: 22/2014

03/2014: Explosion on board M/V "NAKHODKA"  
(See the full Report [here.](#))

**Name of vessel:** NAKHODKA  
**Type of vessel:** General Cargo  
**Year of built:** 1978  
**Flag:** Russian

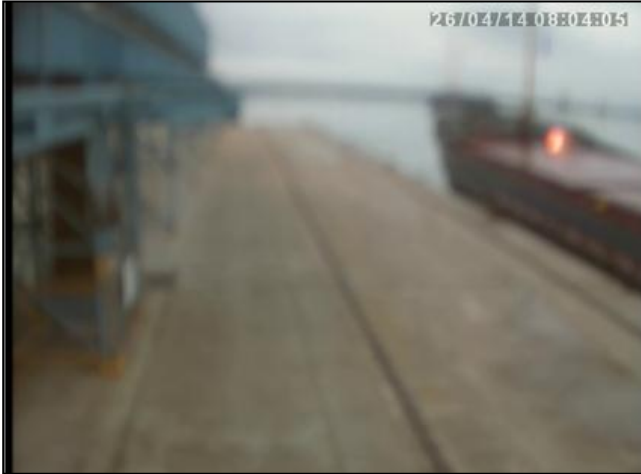
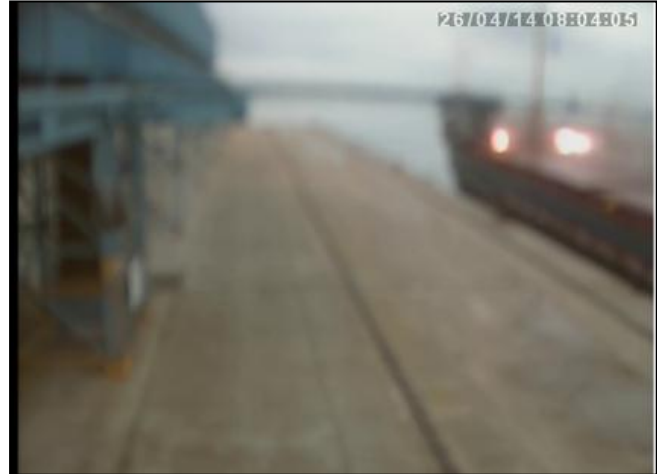
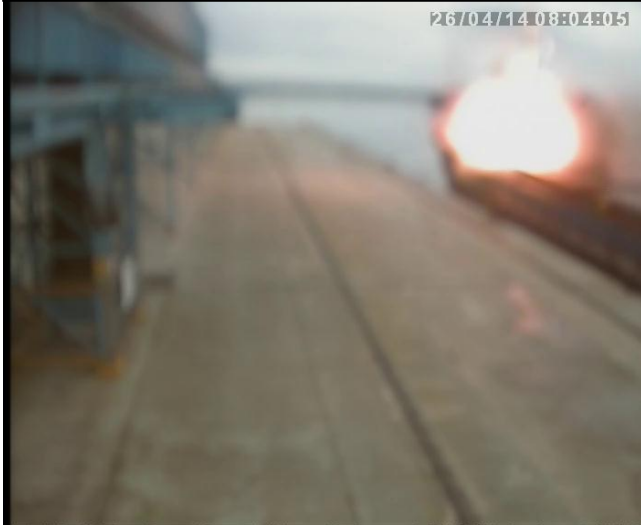
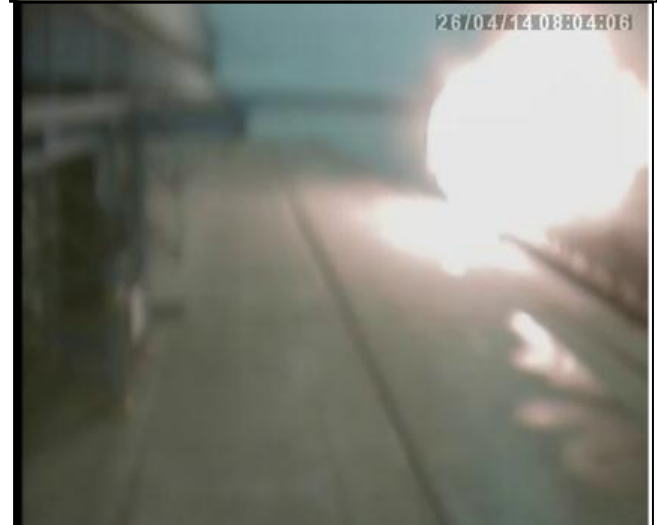
The vessel sustained damages due to the explosion and the fire, in the forecabin, such as distortion of bulkheads and burning of equipment.

*Photos from the explosion*

The casualty was caused by the ignition of propane gas that had leaked from the storage bottle and accumulated at the lower levels of the Boatswain's Store. The ignition source could not be identified; however spark from unprotected lighting equipment found at the area or spark caused by static electricity or friction/impact of metal tools or other metallic equipment were highlighted as possible sources.

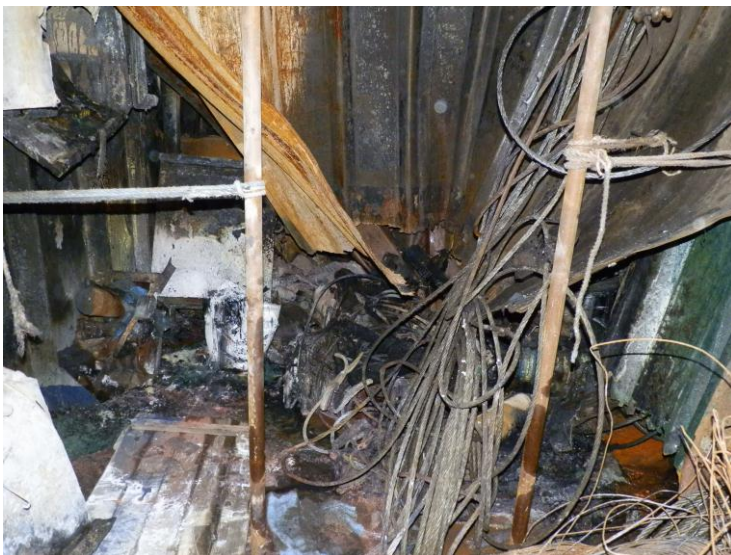
*Capture of the cracked bulkhead of the Paint Room caused by the explosion.*
