## SAFETY RECOMMENDATION No: 23/2013

<b>No of Safety Investigation Report:</b>	04/2013: Foundering of tug boat "ARTEMIS V" by M/V "JSM" (See the full Report <a href="#">here.</a> )
---	--

#### Foundering of tug boat and death of a seaman

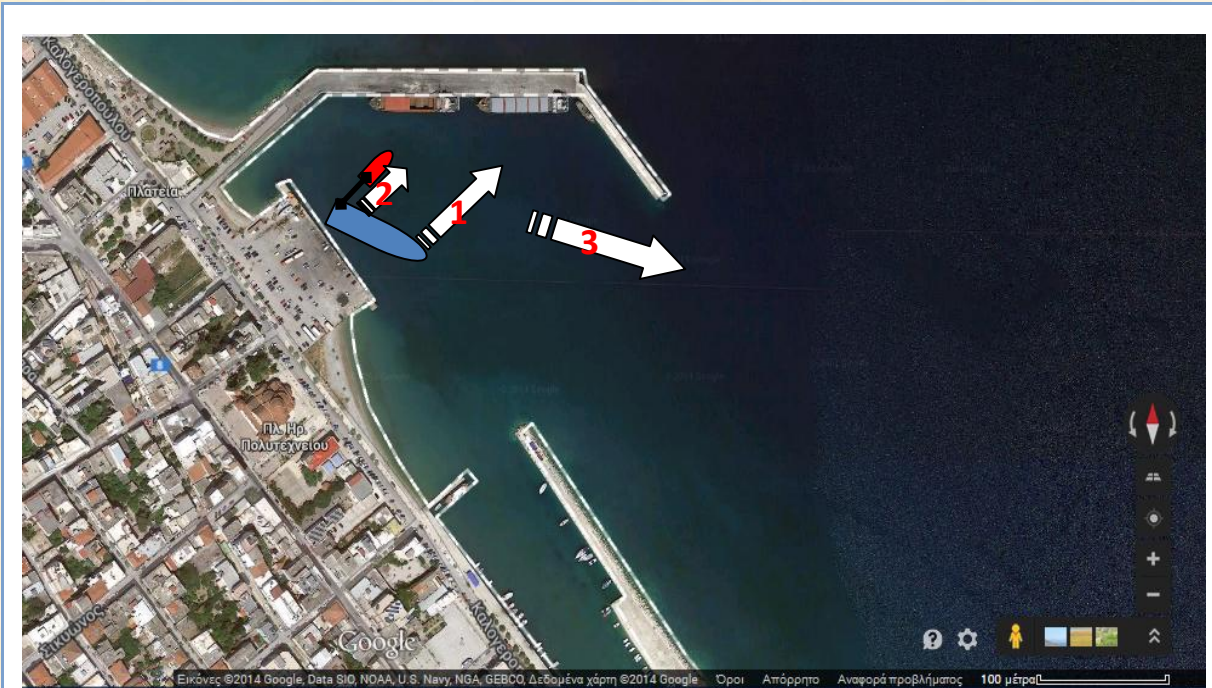
**Picture 1:** Schematic illustration of the maneuvering as planned by the Master of JSM (blue vessel):

- (1) casting the bow off the dock by vessel's lines,
- (2) sheering vessel's stern off the dock by ARTEMIS (red boat), so that JSM was able to head to port exit,
- (3) JSM exits from the port with her means.

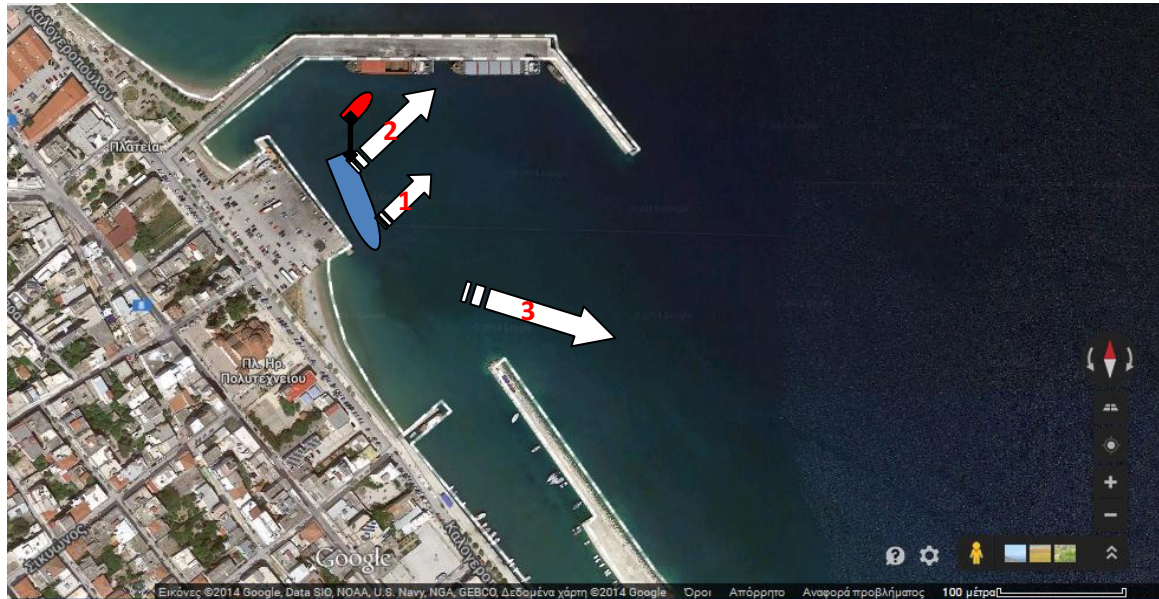
The M/V cast off her bow from the pier by using the stern spring (aft spring line) and according to the plan the stern would be drawn away by the tug boat. However, according to the master of the M/V the tug boat pulled more power than expected the stern of the M/V resulting in giving her a heading which posed a risk of grounding or crashing on the jetty of the fishing shelter of the port.

The increase of speed by the M/V, with heading hard to port in order to prevent the hazardous situation, as the tug boat did not release the towline, created increasing list to the starboard of the tug boat (athwartships forces on the tugboat – high risk situation "T"), so that the tug boat suffered water ingress and consequent sank. The M/V continued her movement and left the port after collecting the towline, which was self-released by the hook of tug boat due to buoyancy.

**Picture 2:** Schematic illustration of the maneuvering of JSM (blue vessel):

- (1) casting JSM bow off the dock by vessel aft spring line,
  - (2) sheering JSM stern off the dock by ARTEMIS V (red boat), causing a rapid turn of JSM bow to starboard and towards the dock, rendering ship's position in a hazardous situation in relation to her safe exit from the port.
  - (3) JSM exit from the port with her own means while pulling ARTEMIS V as she was being dragged on sea bed.
- (The dimensions of vessels and towline are not scaled. Map Source: Google Maps, <http://maps.google.com/>)

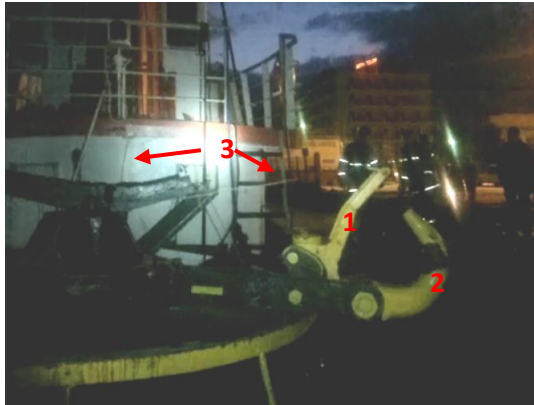
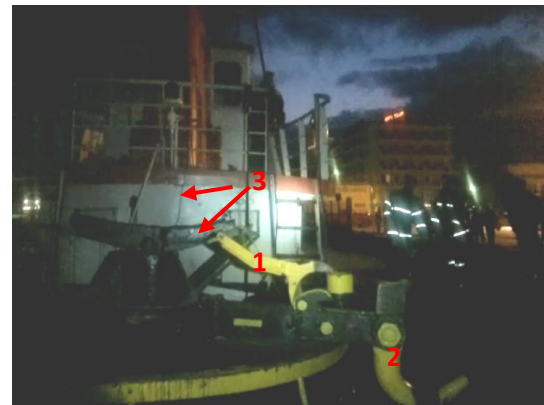
Additionally the weathertight - watertight openings of tug boat were left open during the towage, while the arrangement for releasing the tug's tow line was only operated from inside the wheelhouse and was not ergonomic and especially for use in hazardous or emergency situations precarious list of the boat. Thus the release of the tow line was not performed when the tug boat suddenly developed increasing list.

**Picture 3:** Arrangement of the quick release mechanism of ARTEMIS V. The releasing phases prior to activation (on the left) and past activation (on the right). 1: Hook fastening arm, 2: Towing hook, 3: Release wire from the coupled jointed arm to the bridge.

Provide tugboat "ARTEMIS V" with an alternative arrangement for the towline release at a location other than the bridge and also on other Tugs under its management which do not have such an arrangement.

The concern from the managing companies of tugboats to provide with an alternative arrangement for the towline release at a location other than the bridge all the Tugs under their management which do not have such an arrangement.

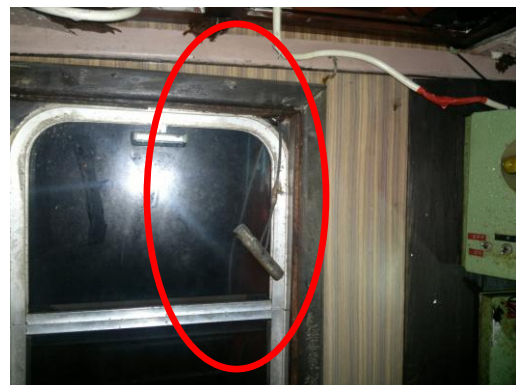
**Picture 4:** The lever release of the immediate release system of the tugs to the steering space of tug boat.
