SAFETY RECOMMENDATION No: 23/2014

03/2014: Explosion on board M/V "NAKHODKA"
(See the full Report [here.](#))

Casualty information

Name of vessel: NAKHODKA
Type of vessel: General Cargo
Year of built: 1978
Flag: Russian

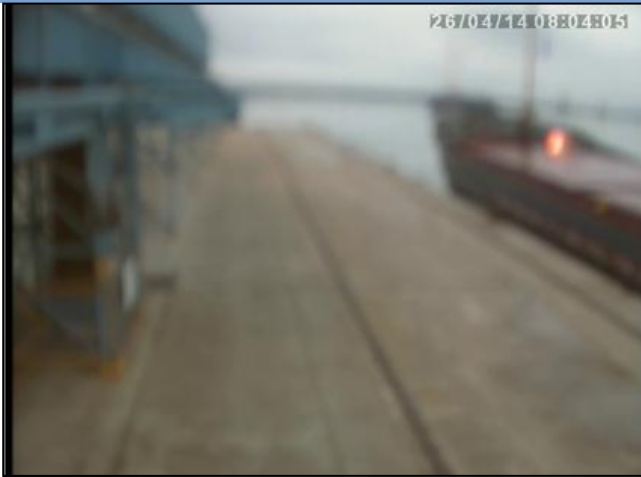
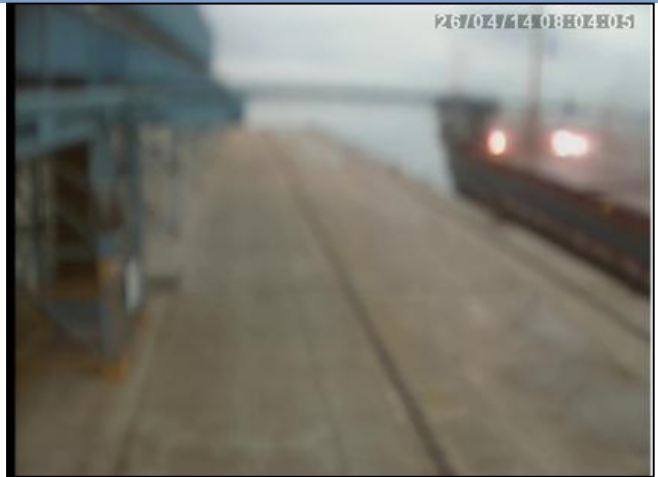
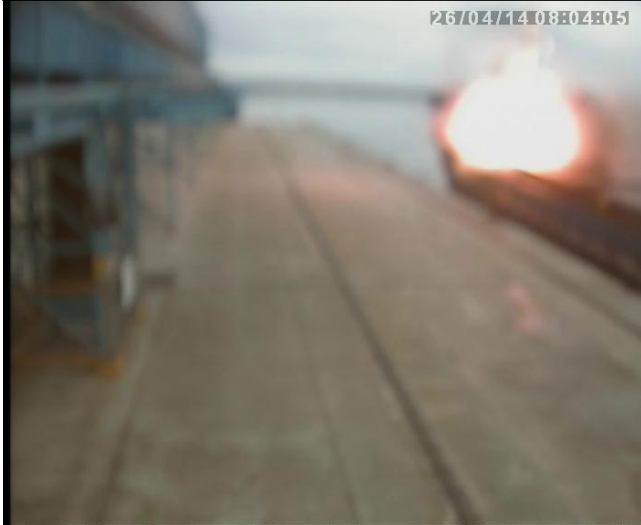
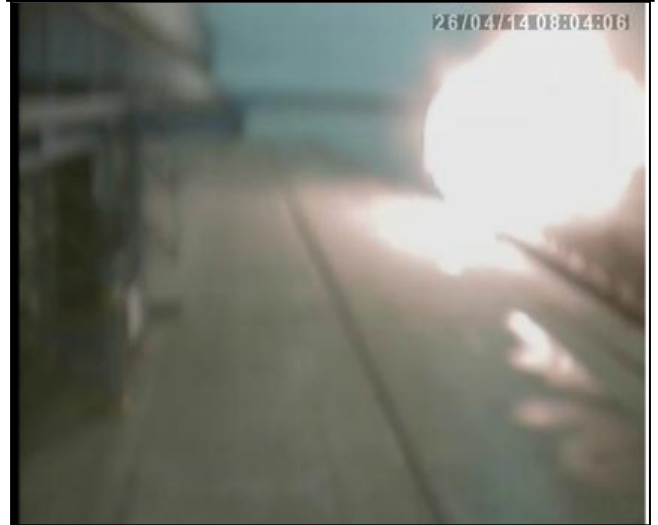
Photos from the explosion

The vessel sustained damages due to the explosion and the fire, in the forecastle, such as distortion of bulkheads and burning of equipment.
