SAFETY RECOMMENDATION No: 24/2013

No of Safety Investigation Report:	04/2013: Foundering of tug boat "ARTEMIS V" by M/V "JSM" (See the full Report here.)
Safety Recommendation addressed to:	Managing Company of M/V "JSM"
Date of publication:	17/11/2014

Foundering of tug boat and death of a seaman

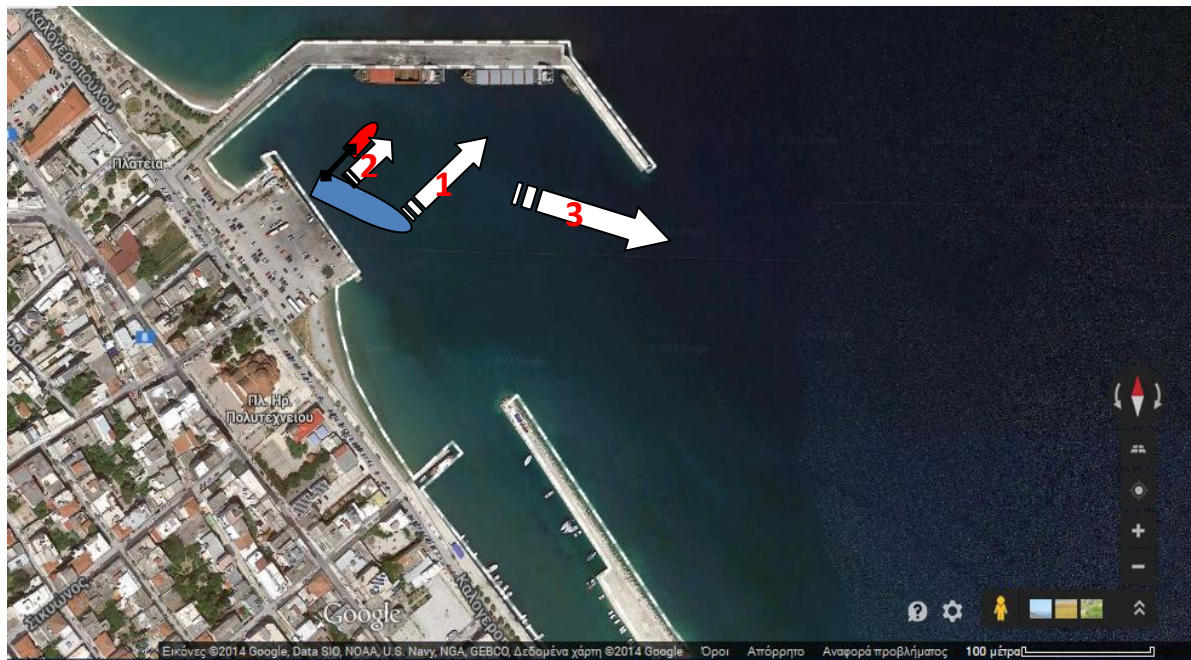
Picture 1: Schematic illustration of the maneuvering as planned by the Master of JSM (blue vessel):

- (1) casting the bow off the dock by vessel's lines,
- (2) sheering vessel's stern off the dock by ARTEMIS (red boat), so that JSM was able to head to port exit,
- (3) JSM exits from the port with her means.

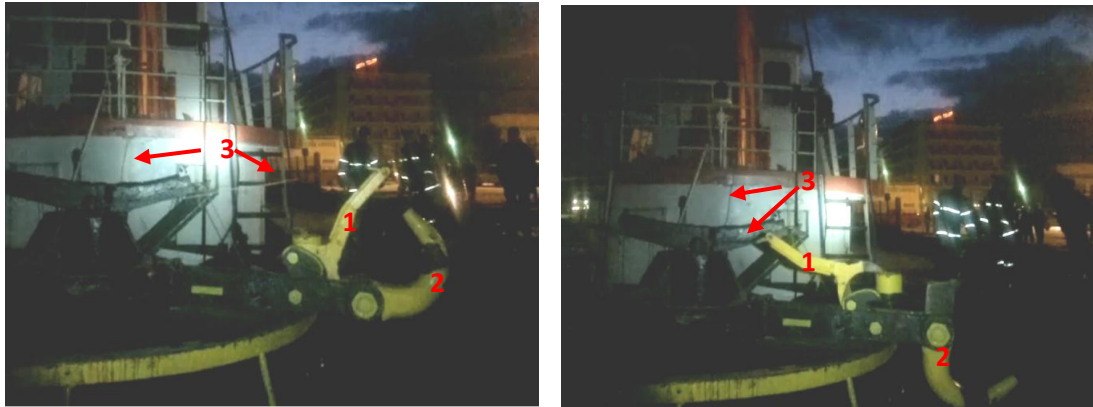
Additionally the weathertight - watertight openings of tug boat were left open during the towage, while the arrangement for releasing the tug's tow line was only operated from inside the wheelhouse and was not ergonomic and especially for use in hazardous or emergency situations precarious list of the boat. Thus the release of the tow line was not performed when the tug boat suddenly developed increasing list.

Picture 3: Arrangement of the quick release mechanism of ARTEMIS V. The releasing phases prior to activation (on the left) and past activation (on the right). 1: Hook fastening arm, 2: Towing hook, 3: Release wire from the coupled jointed arm to the bridge.

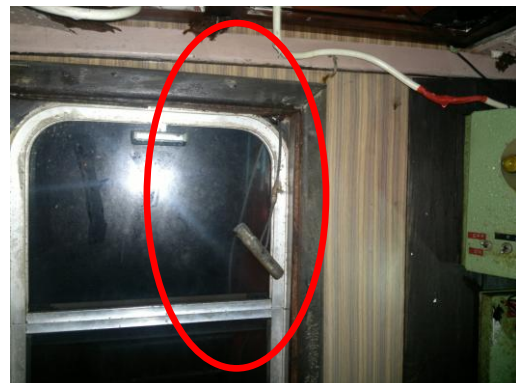
Picture 4: The lever release of the immediate release system of the tugs to the steering space of tug boat.
