SAFETY RECOMMENDATION No: 25/2013

No of Safety Investigation Report:	05/2013: Death of visitor on board Ro-Pax "NISOS RODOS" <i>(See the full Report here.)</i>
Safety Recommendation addressed to:	Owner / Management Company of Ro-Pax "NISOS RODOS"
Date of publication:	26/11/2014

Death of visitor on board Ro-Pax

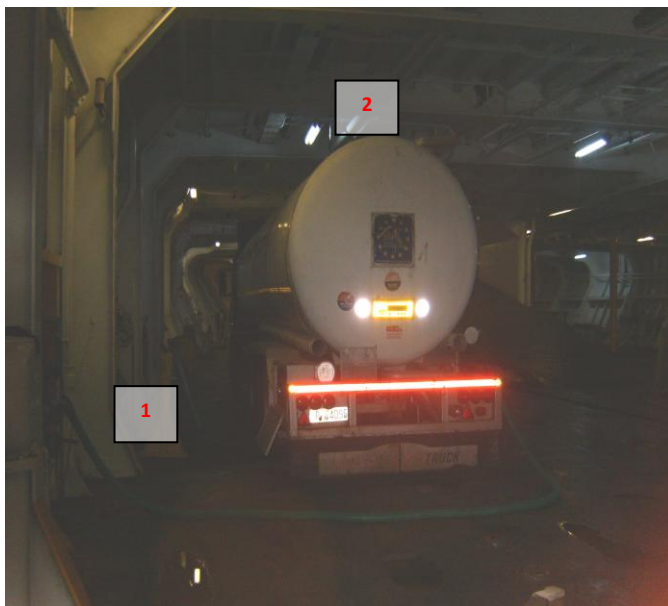
Picture 1: The tank truck parked near the water inlet valve, inside the garage of the Ro-Pax “NISSOS RODOS”. The water pipe, connected to the ship’s fresh water inlet valve is noticed. The position of the Boatswain (1) and the position of the driver (2) during the development of the accident have been marked.

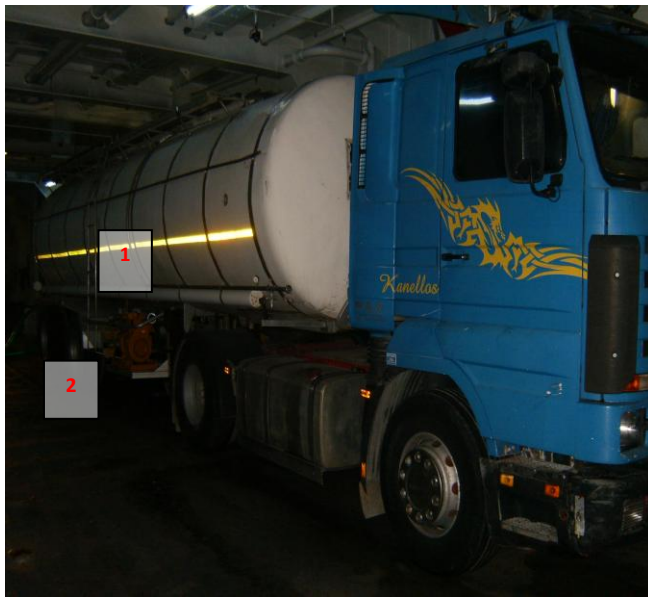
Picture 2: The tank truck parked at the point of the water supply, in the garage of the Ro-Pax "NISSOS RODOS". The ladder on the right side of the tank (1) and the place where the injured was found (2) have been marked.

According to the findings of the forensic report, the loss of life of the visitor of the Ro-Pax occurred "as a result of head, neck and chest injuries, compatible with a fall" and therefore it was the result of falling off the tank truck's ladder.

It is noted that there had been no risk assessment for the ship's water supply process, while the co-driver of the tank truck, who was in the cabin of the truck, entered in the area of the main garage as a visitor, not having been checked by the ship's personnel and not having been accompanied by a crew member, as provided in the Safety Management Manual of the ship and the ship's Security System.

The issue of an internal circular by the managing companies to ships managed, with which to underline to the crews the proper observance of entry checks to visitors of the ship under the SMM and the SSP and especially to co-drivers on vehicles that provide services to the ship.
