## SAFETY RECOMMENDATION No: 26/2013

<b>No of Safety Investigation Report:</b>	05/2013: Death of visitor on board Ro-Pax "NISOS RODOS" <i>(See the full Report <a href="#">here.</a>)</i>
---	---

#### **Death of visitor on board Ro-Pax**

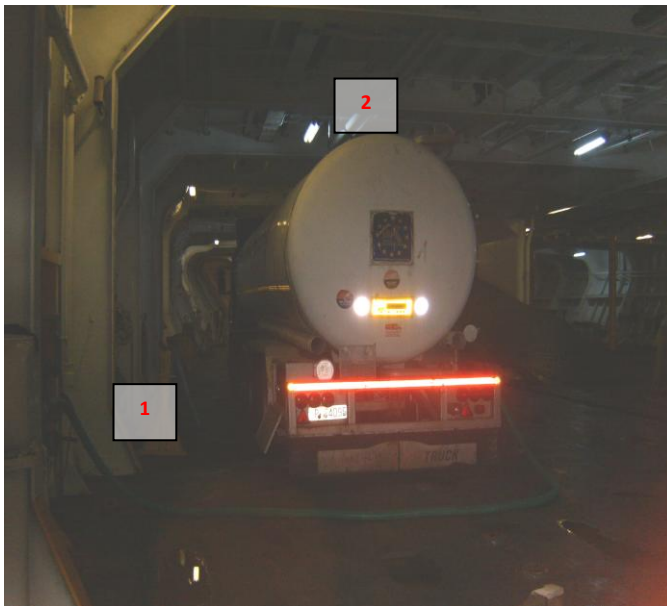
**Picture 1:** The tank truck parked near the water inlet valve, inside the garage of the Ro-Pax “NISSOS RODOS”. The water pipe, connected to the ship’s fresh water inlet valve is noticed. The position of the Boatswain (1) and the position of the driver (2) during the development of the accident have been marked.
