## SAFETY RECOMMENDATION No: 26/2014

03/2014: Explosion on board M/V "NAKHODKA"  
(See the full Report [here.](#))

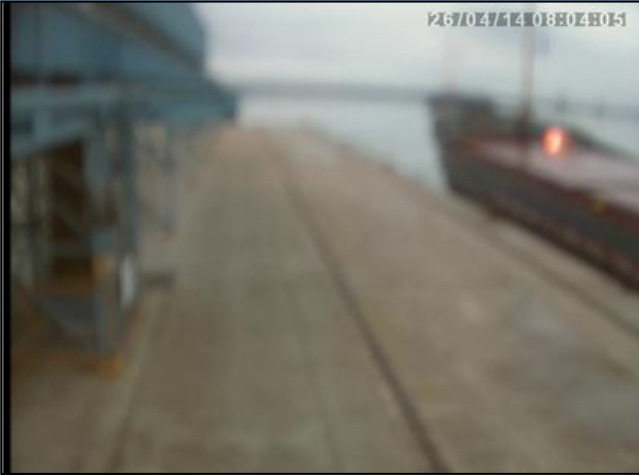
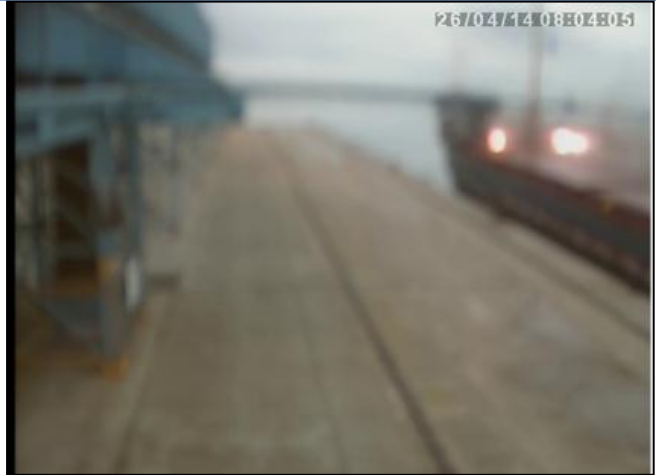
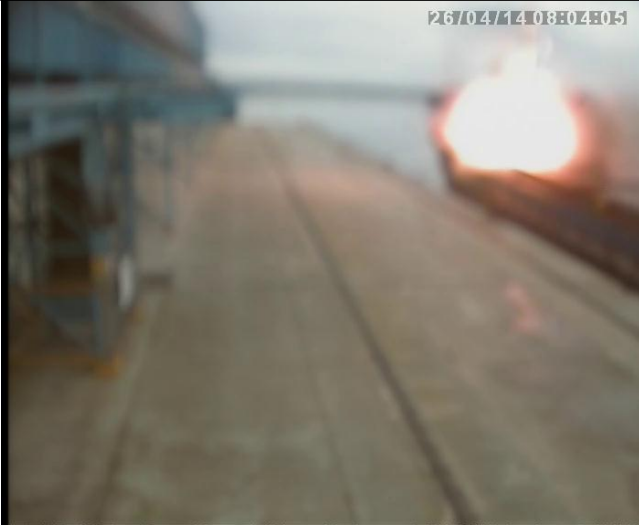
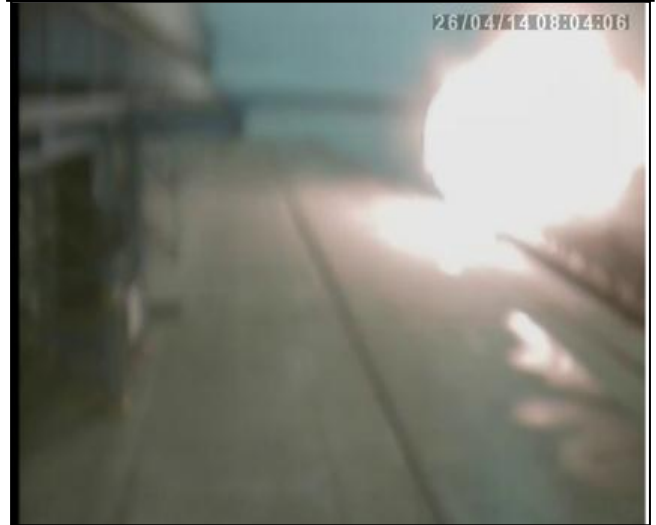
The vessel sustained damages due to the explosion and the fire, in the forecandle, such as distortion of bulkheads and burning of equipment.

*Photos from the explosion*

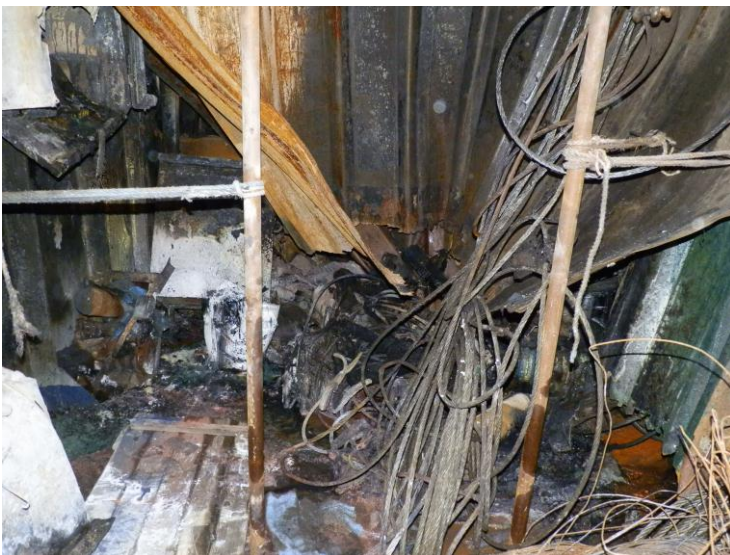
*Capture of the cracked bulkhead of the Paint Room caused by the explosion.*
